**Town of Fairview**  
**Collin County, Texas**

**Fire Station #1 - Condition Assessment Report**

January 2016

**HUITT-ZOLIARS**

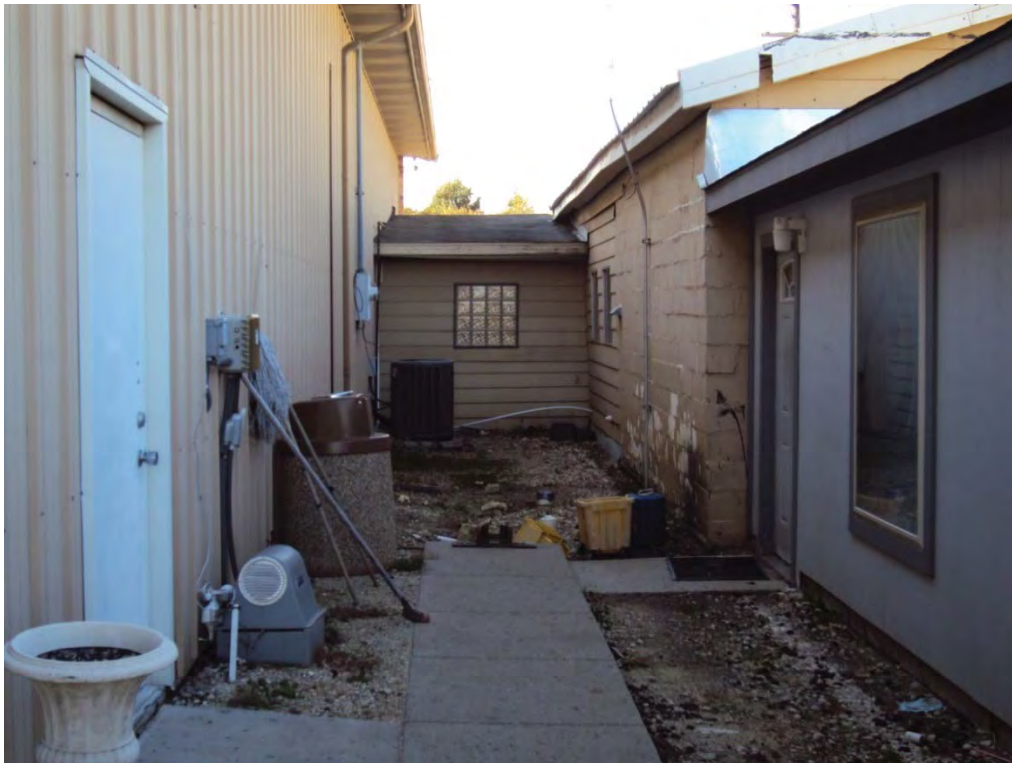
*Photo A2. Building Additions*

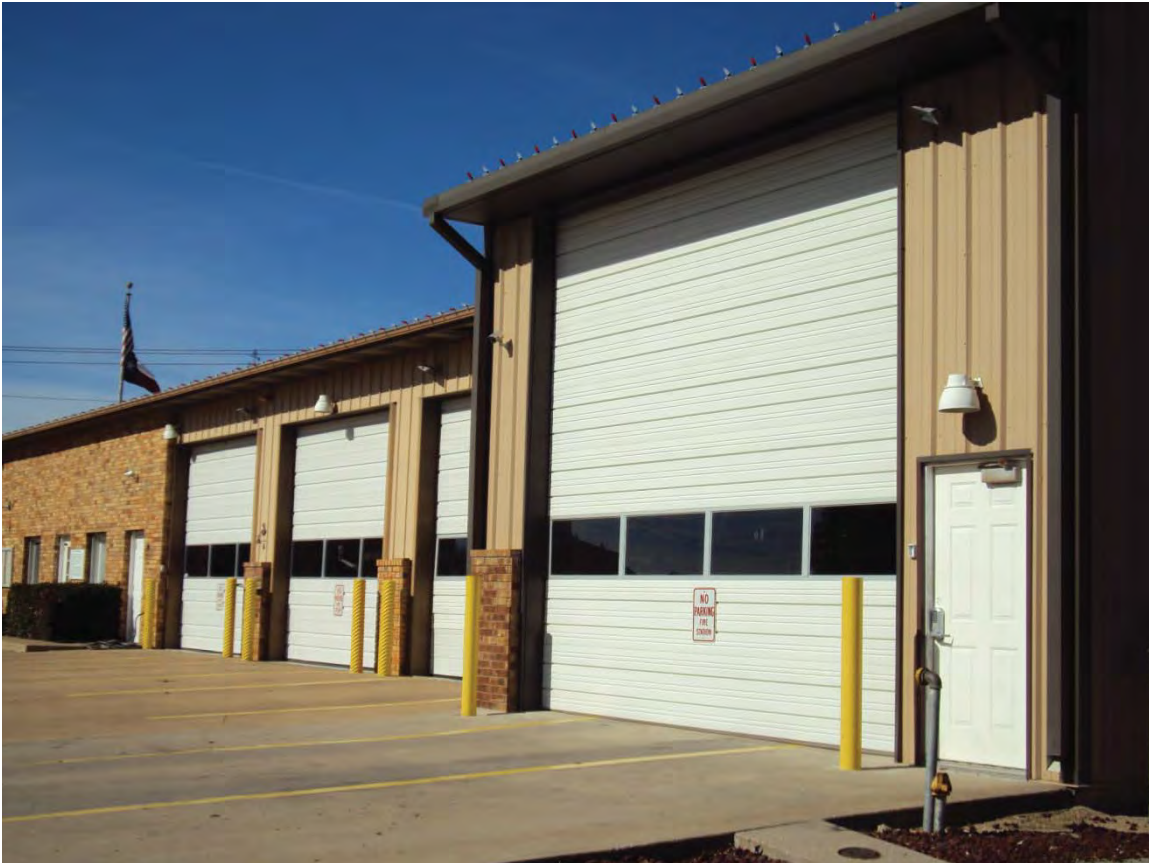
A large portion of one of the latter additions is where the ambulance, engines and apparatuses are stored inside. The exhaust fumes from these vehicles when entering or exiting the bays migrate into the corridor, fitness room, recreation space and offices. This is an unhealthy condition that is being created. The wall that separates the vehicles from the administration spaces is not a rated partition, or properly sealed, but should be.

*Photo A3. Apparatus Bays*

The life safety issues and health concerns should be addressed immediately. This includes the corrections to the structural problems with the roof, the rated partition at the vehicle bay. Shower #1 and the washer and dryer should be relocated; this is a health concern creating an unsanitary condition.

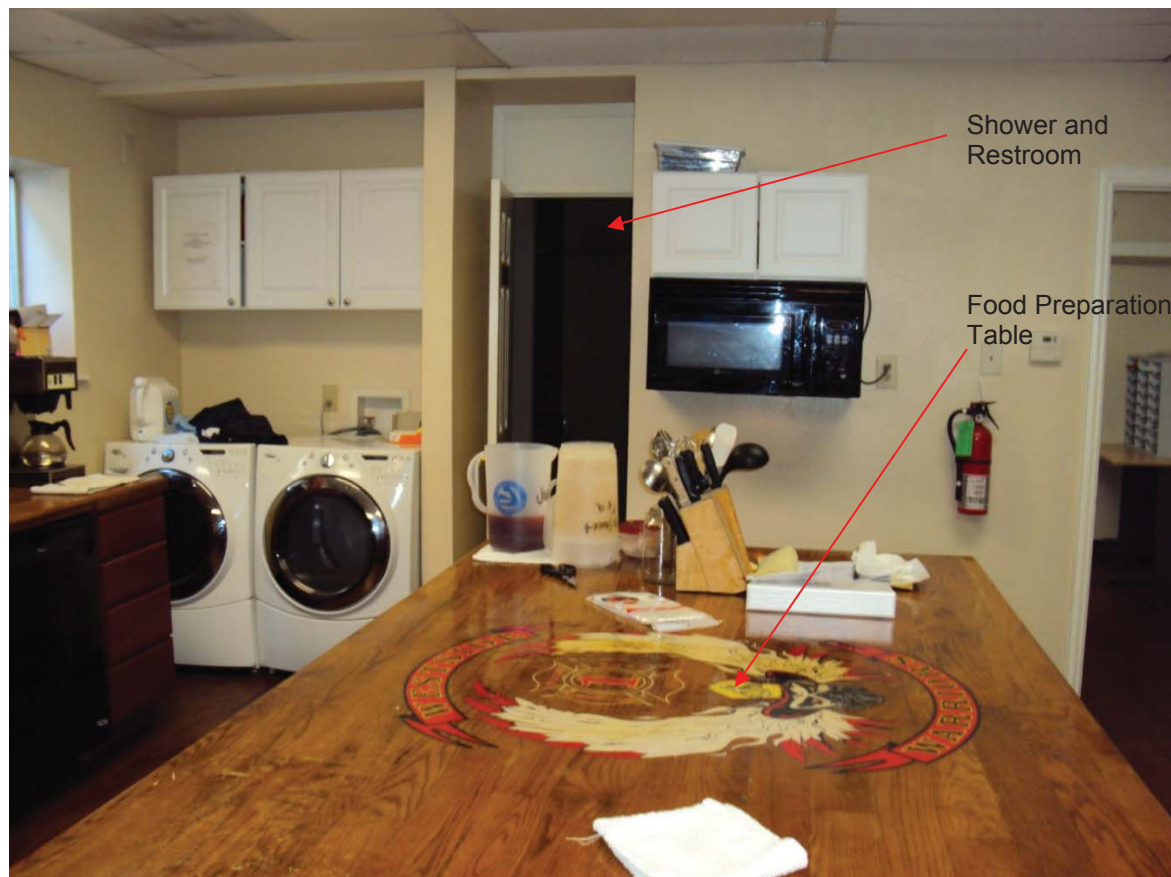
The kitchen area that serves the occupants on each shift has a number of potentially unsanitary condition.

- The door to Shower #1 and a toilet opens directly into the space where food is being prepared.
- A washer and dryer are operated in the kitchen creating an unsanitary condition where food is being prepared.

*Photo A4. Kitchen Area*

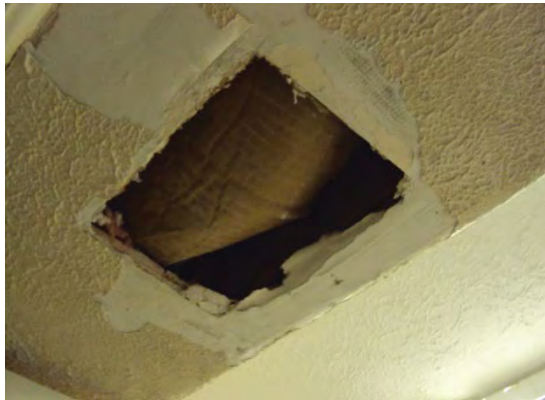
- The numerous additions over the life of this building have created undue maintenance problems.
- Several different types of roofs coupled with different intersections and elevations have evolved into an ongoing roof leak that seems to be unrepairable above Office #5.
- The roof conditions over the original building and the additions are in need of replacement, and are failing structurally in some areas.

*Photo A5. Roof Leak at Ceiling*

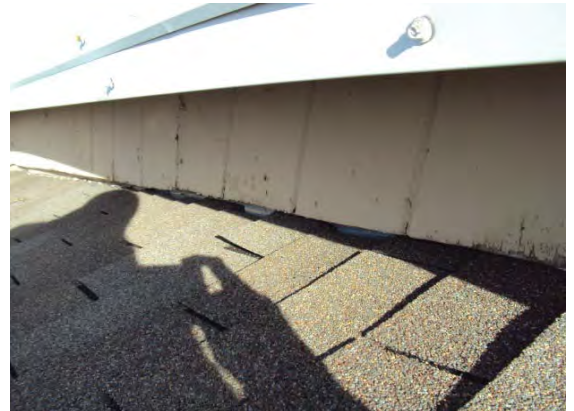
*Photo A7. Roof Addition*

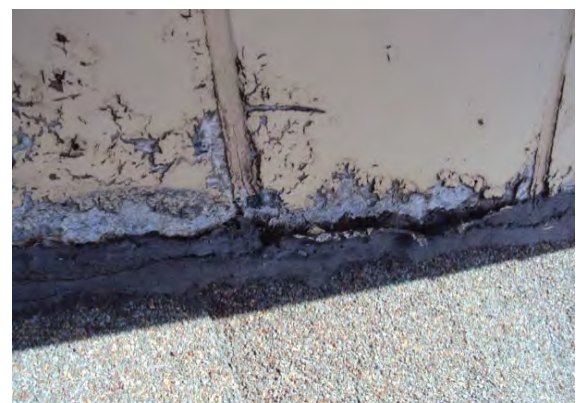
*Photo A8. Deteriorating Sheathing*

The vertical walls where the lower roofs intersect are not properly flashed, the materials and sealants are rapidly deteriorating. To properly address this problem, all the roofing, sidewalls, flashing and sheathing would need to be replaced. However, this would not address the real problem that has been created with existing construction and additions at various elevations and intersections.

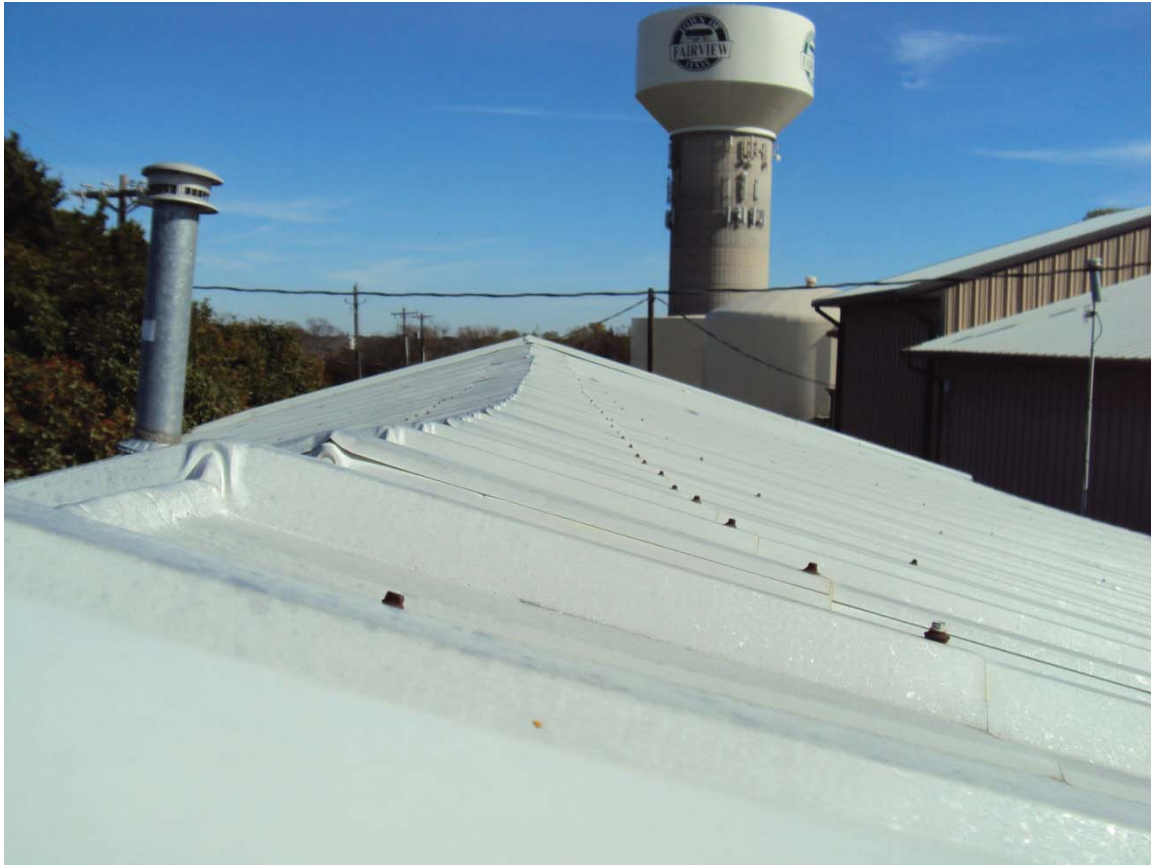
The existing roofs at the original 1960's, 1980's and 1990's addition are showing signs of creep, fatigue and failure. Structural repairs are required. The rafters and decking are sagging in both directions. This is an unsafe condition.

*Photo A9. Roof Creep, Fatigue, Failure*

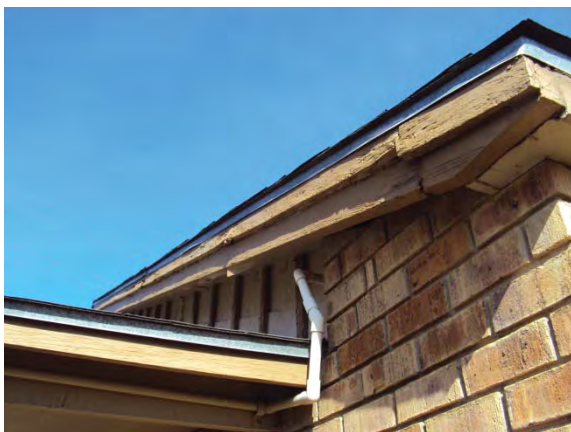
There is ongoing maintenance required for the exterior facade of the facility. The wood trim at the rake and eaves is severely rotted. The concrete masonry unit walls in the 1980's addition are in need of paint and crack repair. Both of these conditions will lead to substantial maintenance costs if not repaired soon. Water and moisture will infiltrate the facility and likely lead to internal water damage of the adjacent spaces.

*Photo A10. Wood Rake and Trim Rotting*

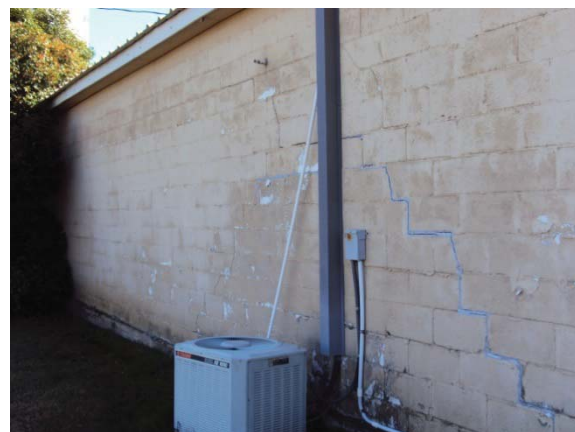
*Photo A11. Cracks at Exterior Facade*

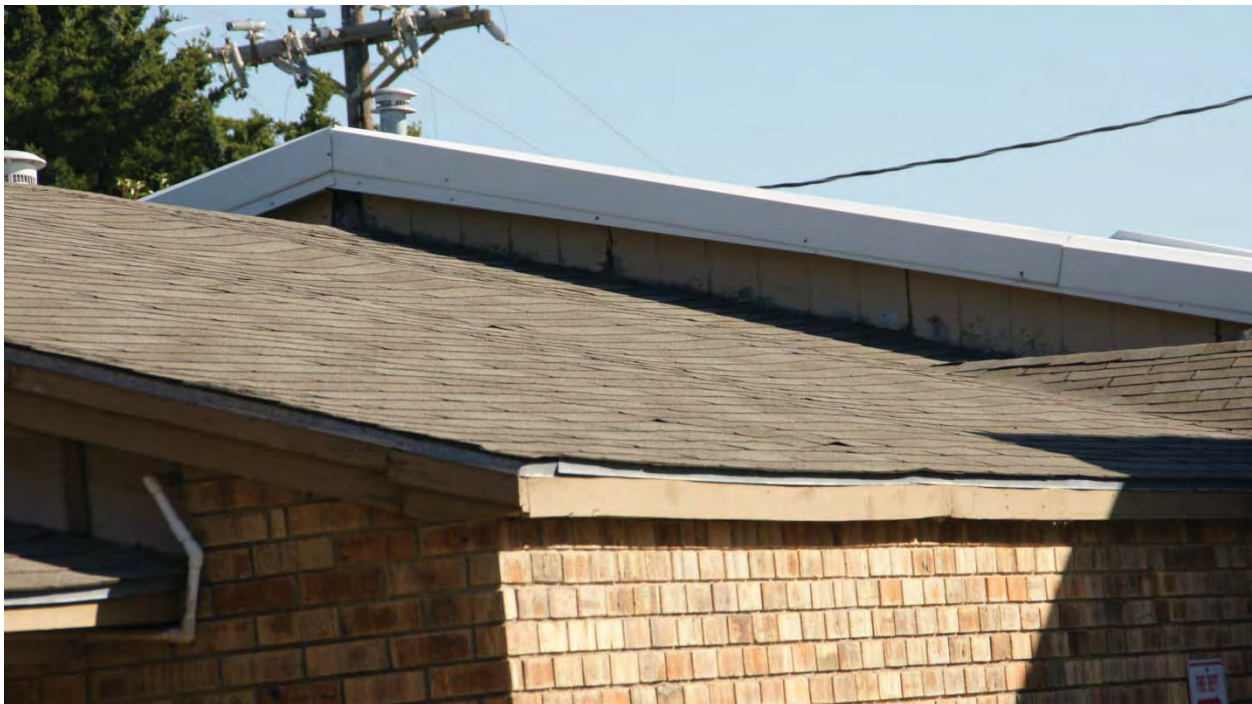
Noticeable rippling/buckling of the composition shingle roof was observed over the original circa 1960 module. Trim and eave boards are in poor condition and in need of replacement/repair.

*Photo S1. Ripples in Roof Over Original Construction (1960's) Module*

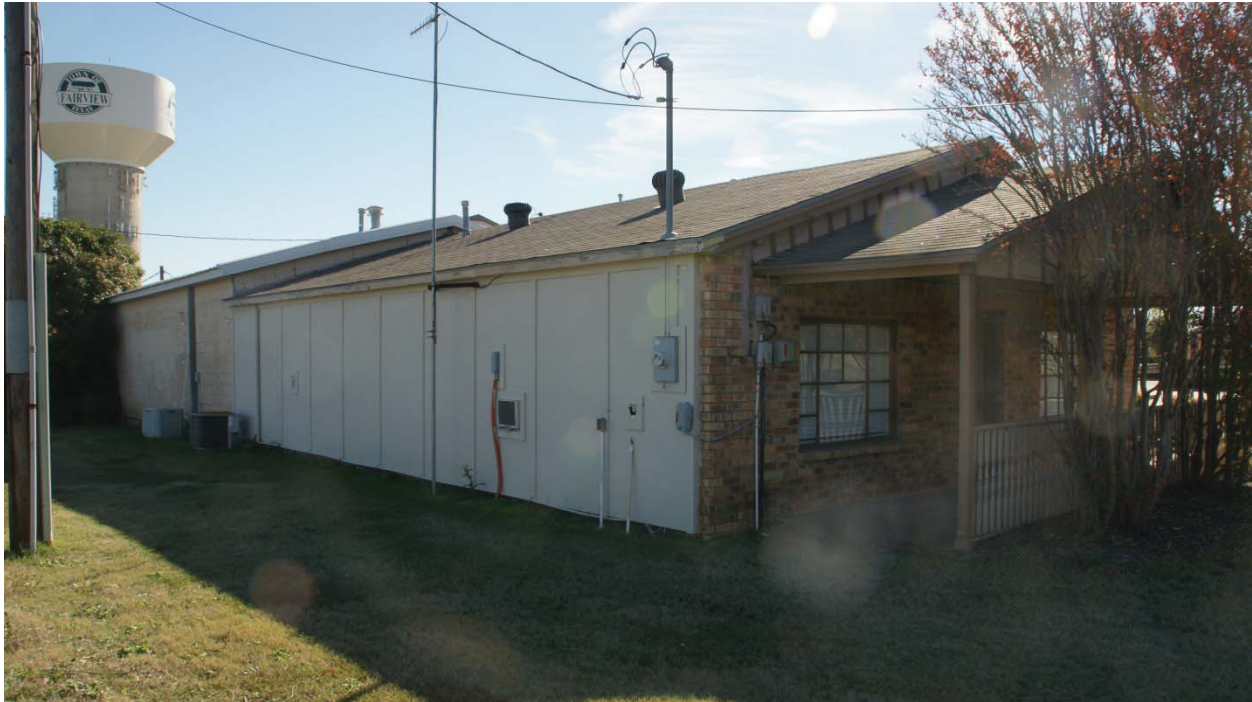
*Photo S2. Northern Half of Roof, Trim, and Siding on 1960 Module*

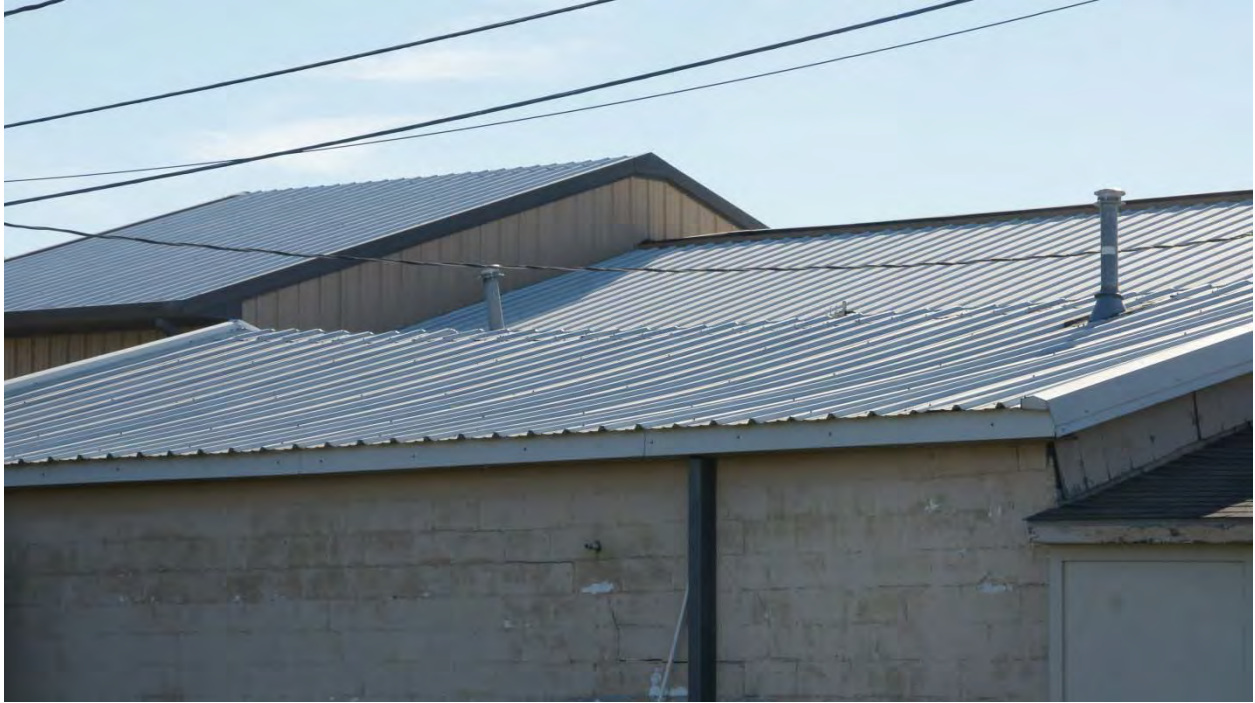
The roof over the circa 1980 addition was found to be sagging in the middle. The sagging appears to be due to a lack of adequate lateral resistance for the rafters in the form of roof ties. Also, everything from the ceiling and above is supported directly or indirectly by these rafters. That includes the HVAC equipment. The rafters could be suffering from overstressing that has exacerbated the creep in deflection that has led to excessive sag. Tension ties in the form of cables have been added across the attic near the east end of this section to resist the lateral thrust from the rafters in this area. As a result, the sagging is significantly less in that area. The entire area of the roof should be shored up and the rafters strengthened/repared as necessary. It was reported that the roof was sagging so much, the ceiling tiles, which are hung from the rafters, were falling out of their grids. The wires supporting the grid were shortened to level the ceiling grid so the ceiling tiles would not slip out. It is unknown how long this sag has been present, but it is a situation that is unsafe as the sagging represents a state of progressive collapse of the roof.

The roof over the 1980's addition is sagging. This appears to be due to inadequate lateral ties at the top of walls to resist the kick-out forces from the roof rafters and loads supported by the rafters. The bottom 2x6 ties are twisted and the rafters are deflecting excessively between the bottom tie and the cmu wall on which they bear. The ceiling grid, HVAC equipment, ceiling grid system, and lights are suspended from the rafters. Possible overstressing of the rafters and exacerbated creep are also suspected. The supporting cmu wall has cracking. Some of this cracking is due to the lateral kick-out at the top of the wall due to the roof rafters pushing out. This roof is in a state of progressive collapse. Shoring and bracing should be provided for the short term. Existing rafters and ceiling joists should be strengthened/replaced and the lateral tie system re-established.

*Photo S3. Sagging Roof*

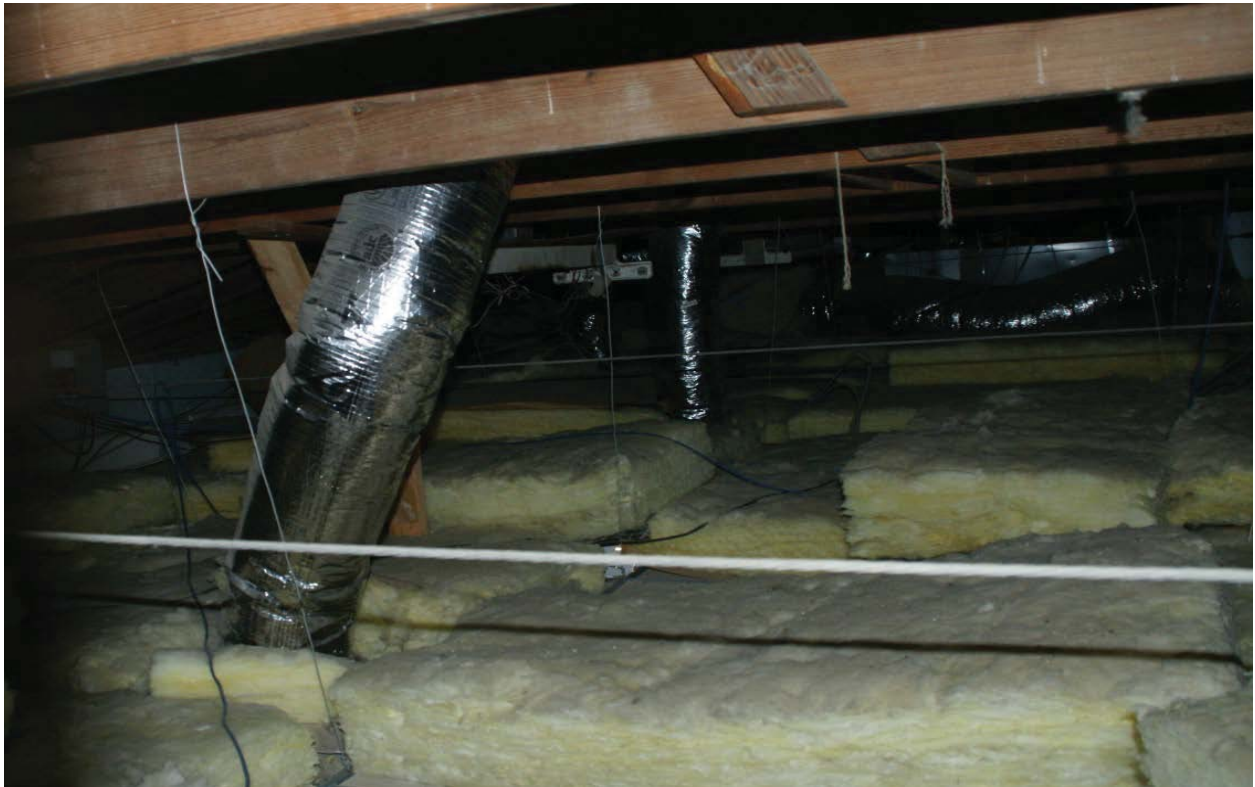
*Photo S4. East End of Attic Space Over 1980's Addition. Notice Cable Tie In Foreground*

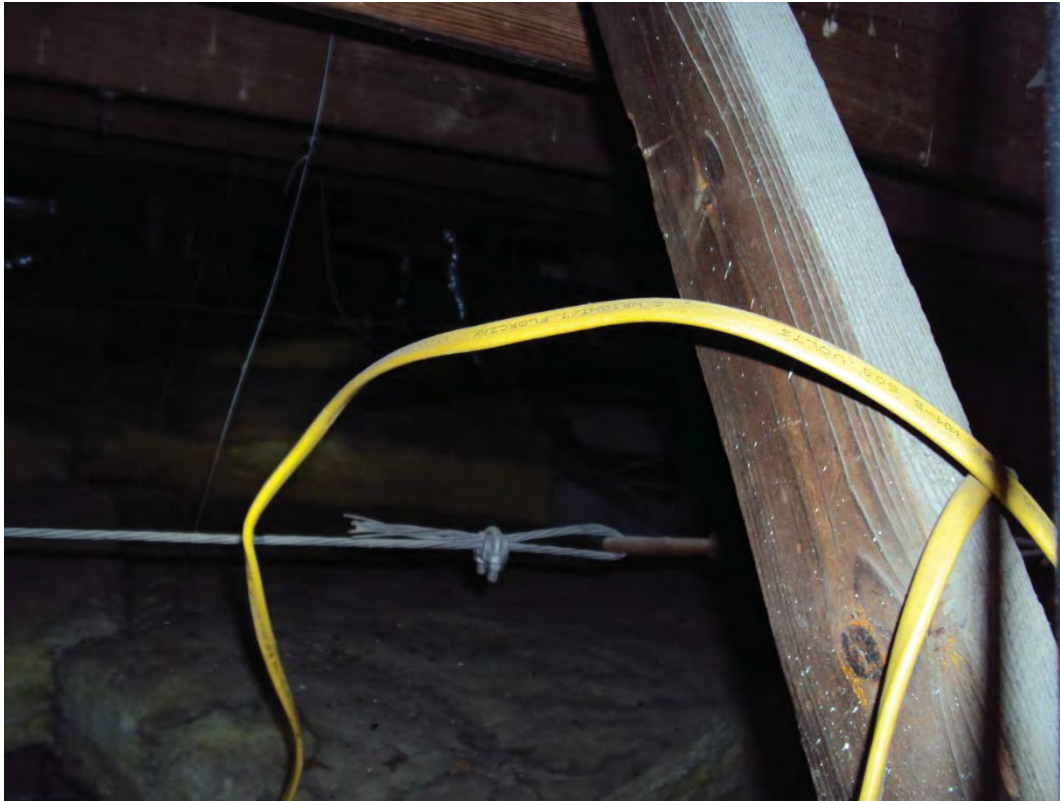
*Photo S5. Cable Spanning Across Attic at East End of Attic*

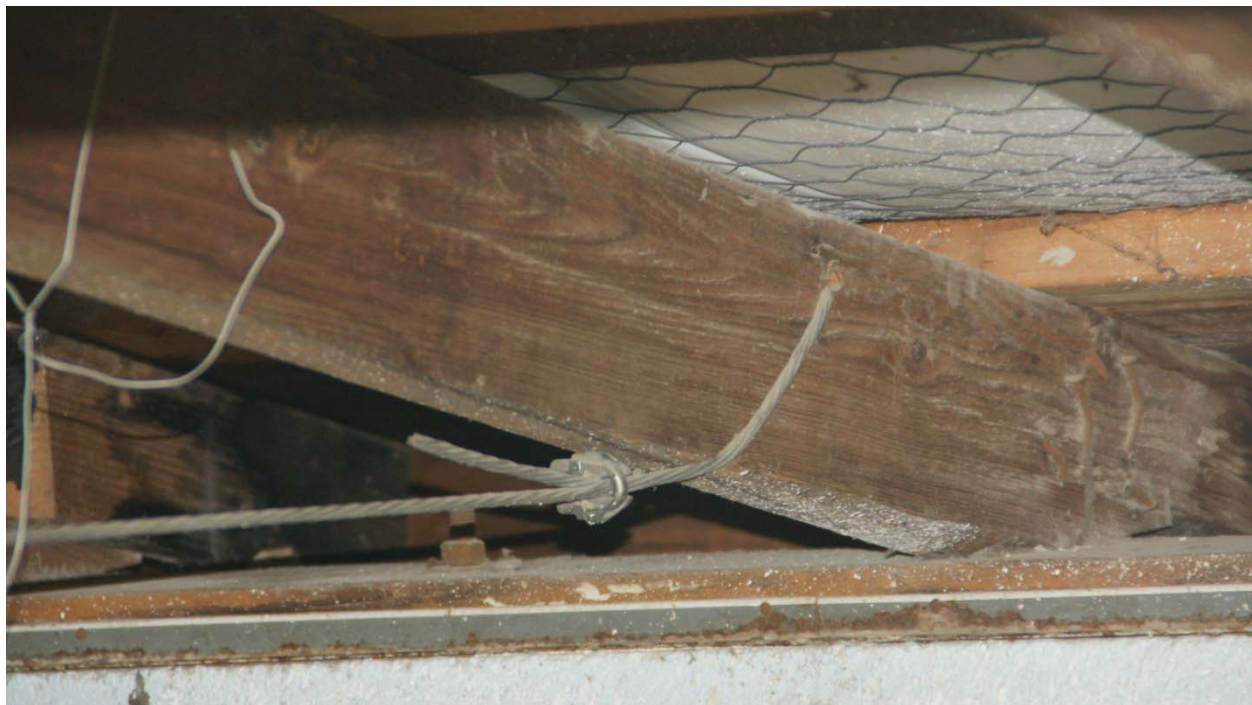
*Photo S6. Cable Connection at Rafter*

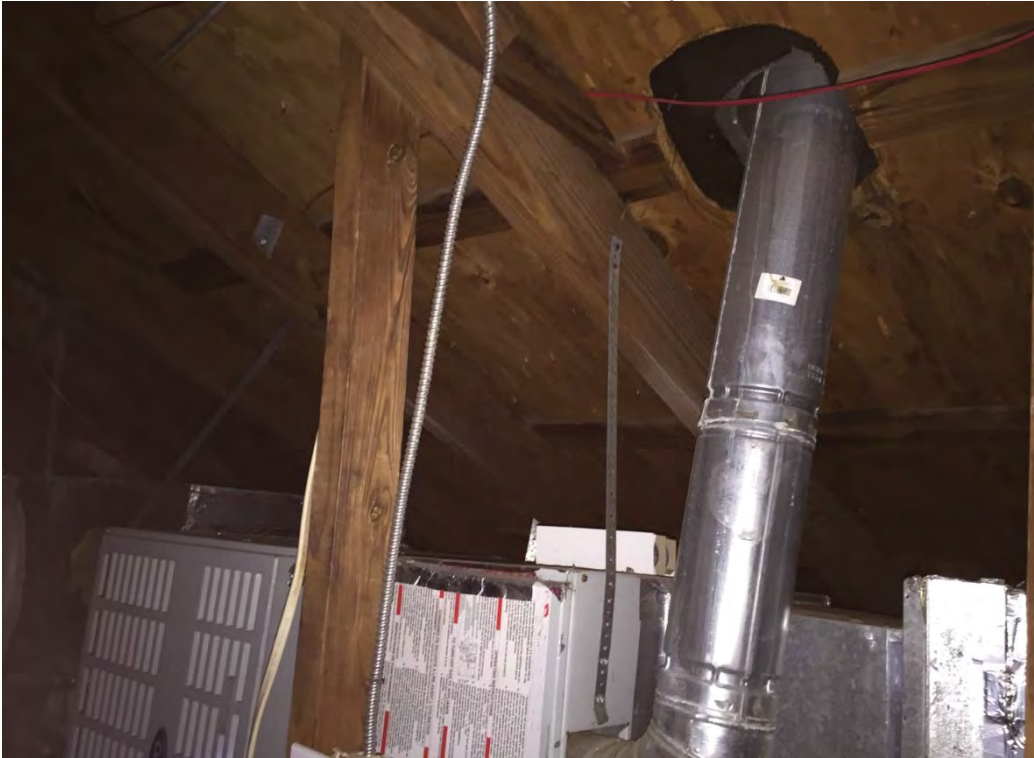
*Photo S7. HVAC Equipment Suspended from Rafters*

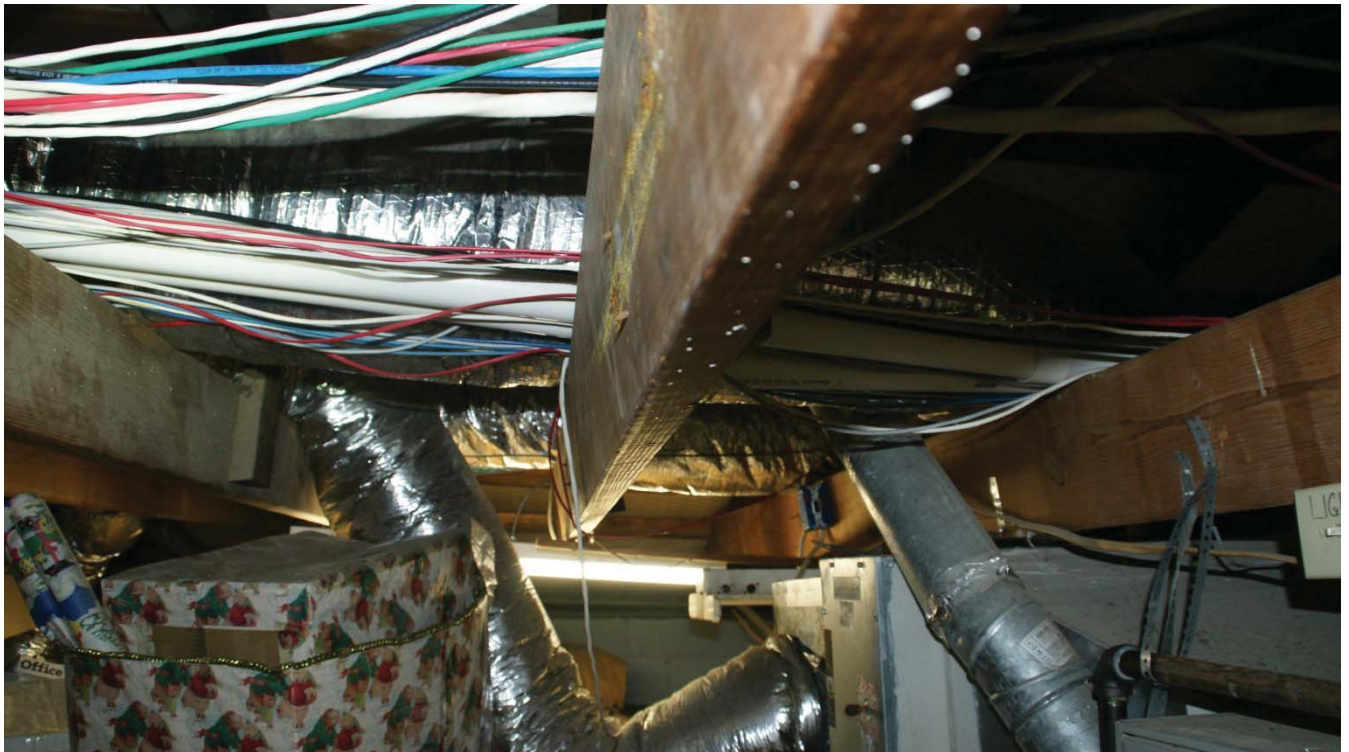
*Photo S8. Twisted Bottom Tie*

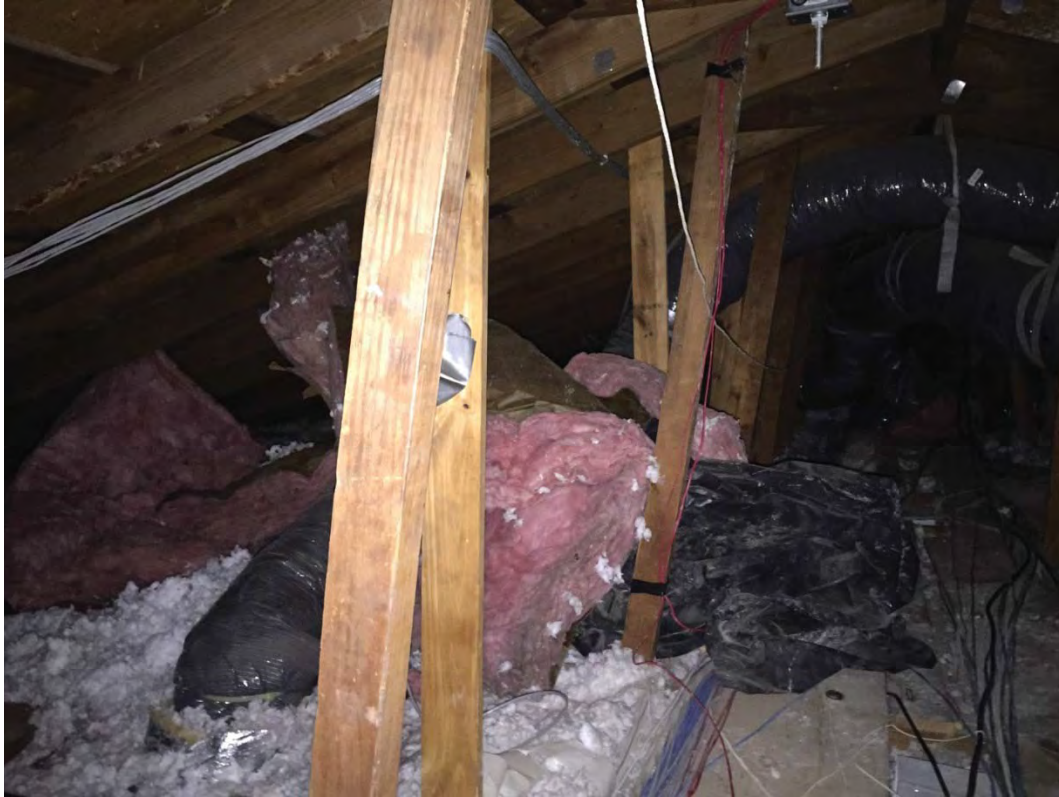
*Photo S9. Ceiling Suspension Framing – Original 1960's Module*

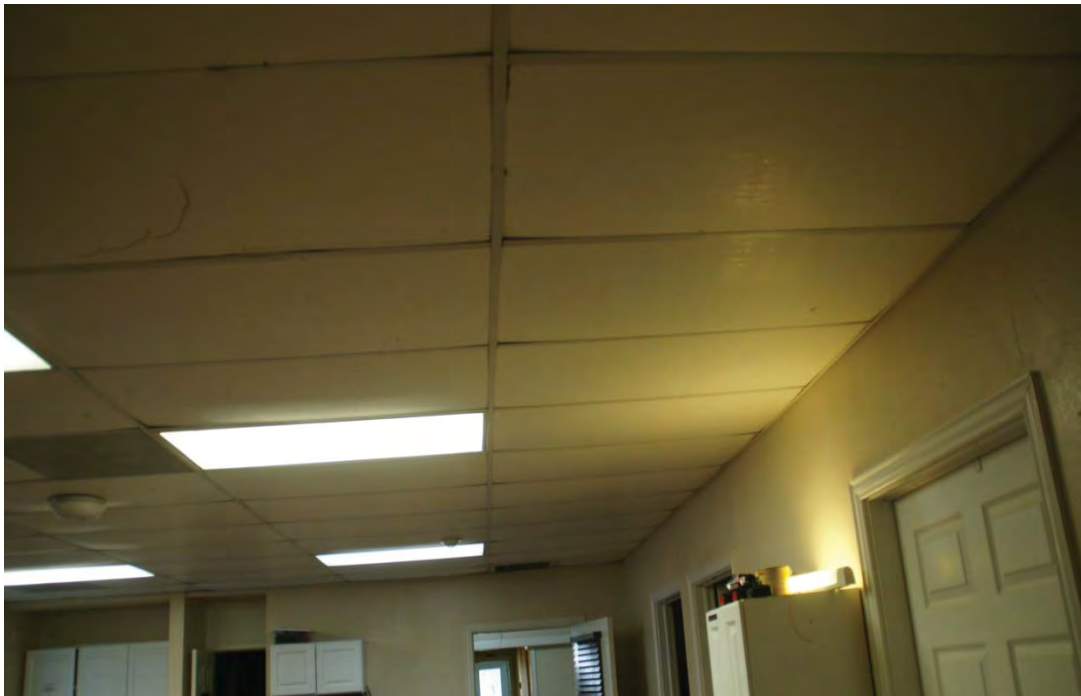
*Photo S10. Suspended Ceiling Hung from Sagging Rafters – 1980's Addition*

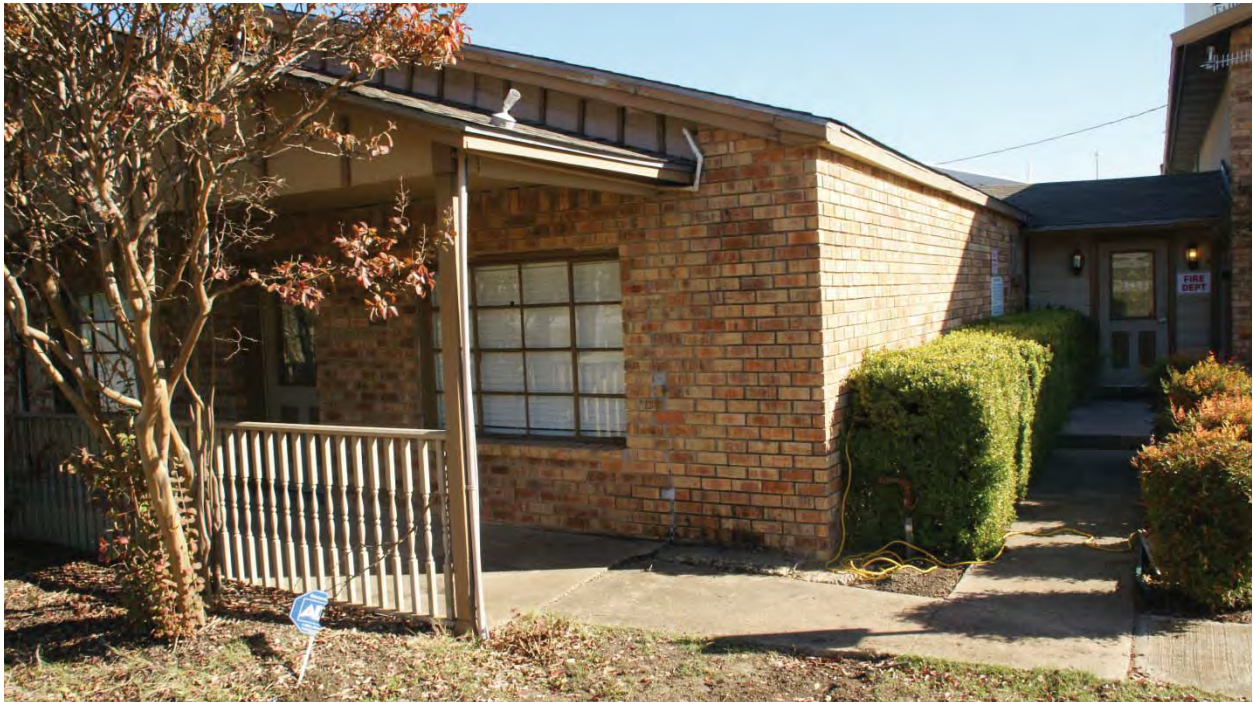
Cracking in the exterior brick and cmu walls was found on the original 1960's module and the 1980's addition. The cracking appears to be related to foundation settlement. The cracking of the cmu wall at the 1980's addition could be magnified by the lateral push from the rafters. There was some cracking above doors in these portions of the building also. The cracking above doors has been repaired previously, but has cracked again. All the doors were operable without binding or sticking. Floors should be surveyed for levelness. As an option, piers could be added around the perimeter to level and close cracks in cmu.

*Photo S11. Cracking in Brick*

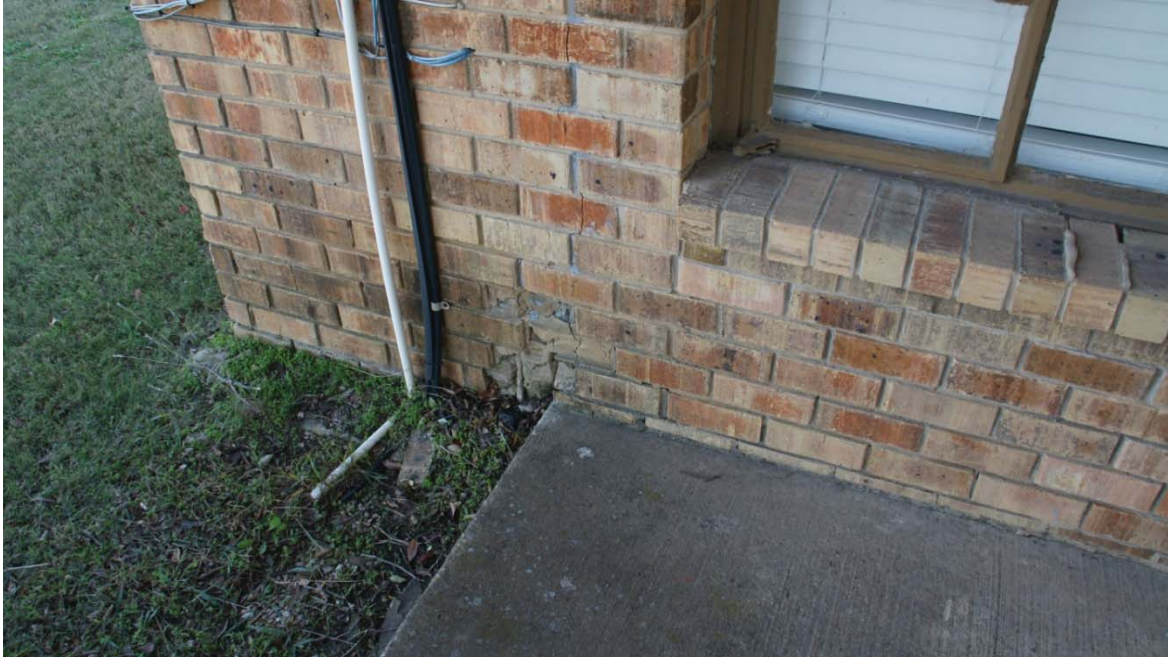
*Photo S12. Cracking in Brick at Opposite Corner*

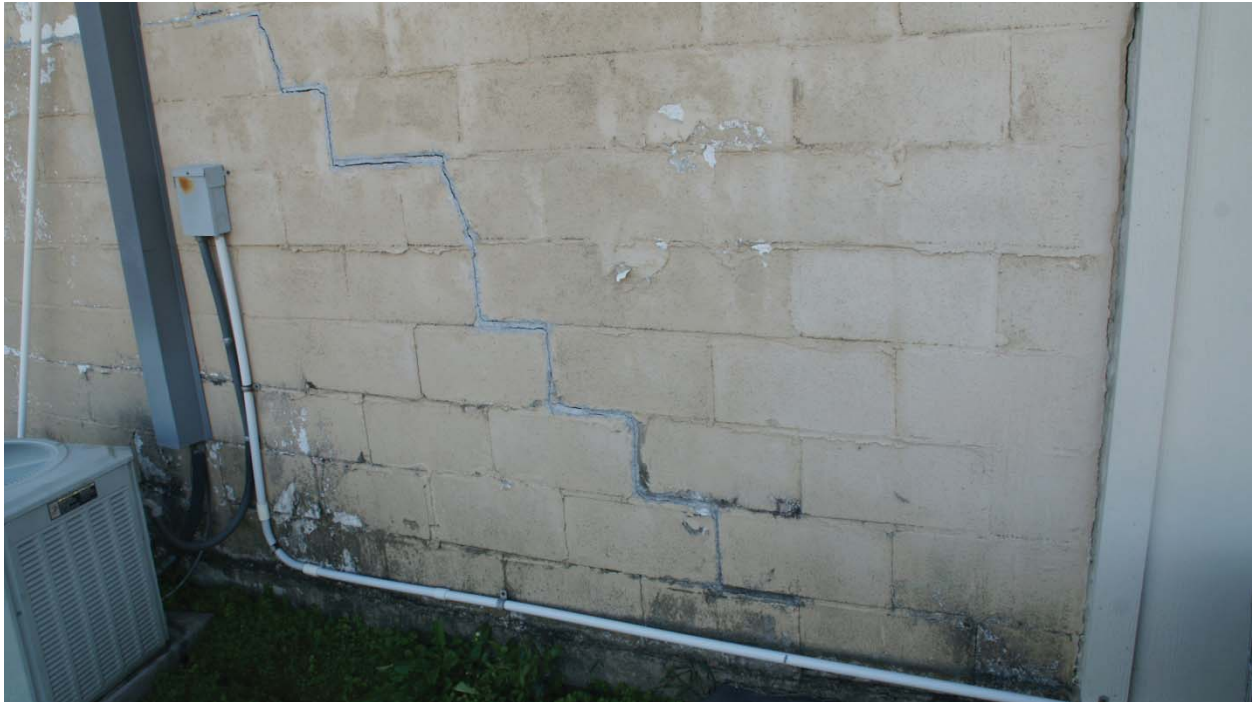
*Photo S13. Cracking in CMU Due to a Combination of Foundation Movement and Lateral Thrust from Rafters*

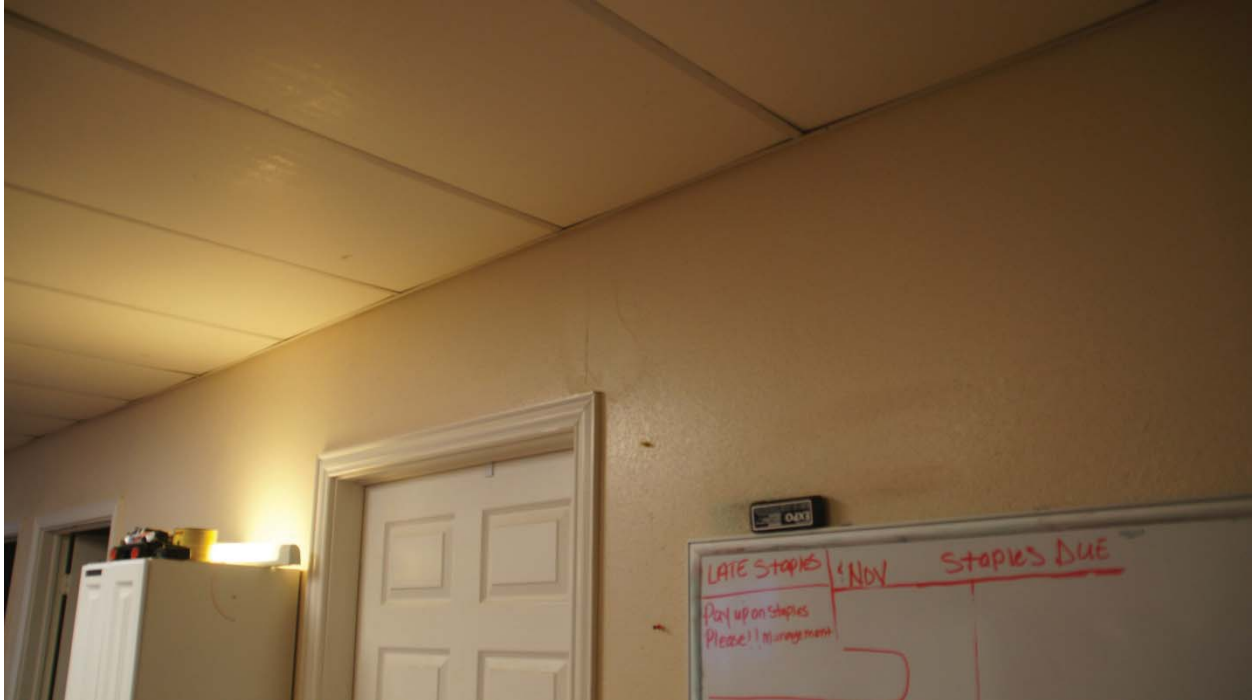
*Photo S14. Cracking Above Doors on the Interior*

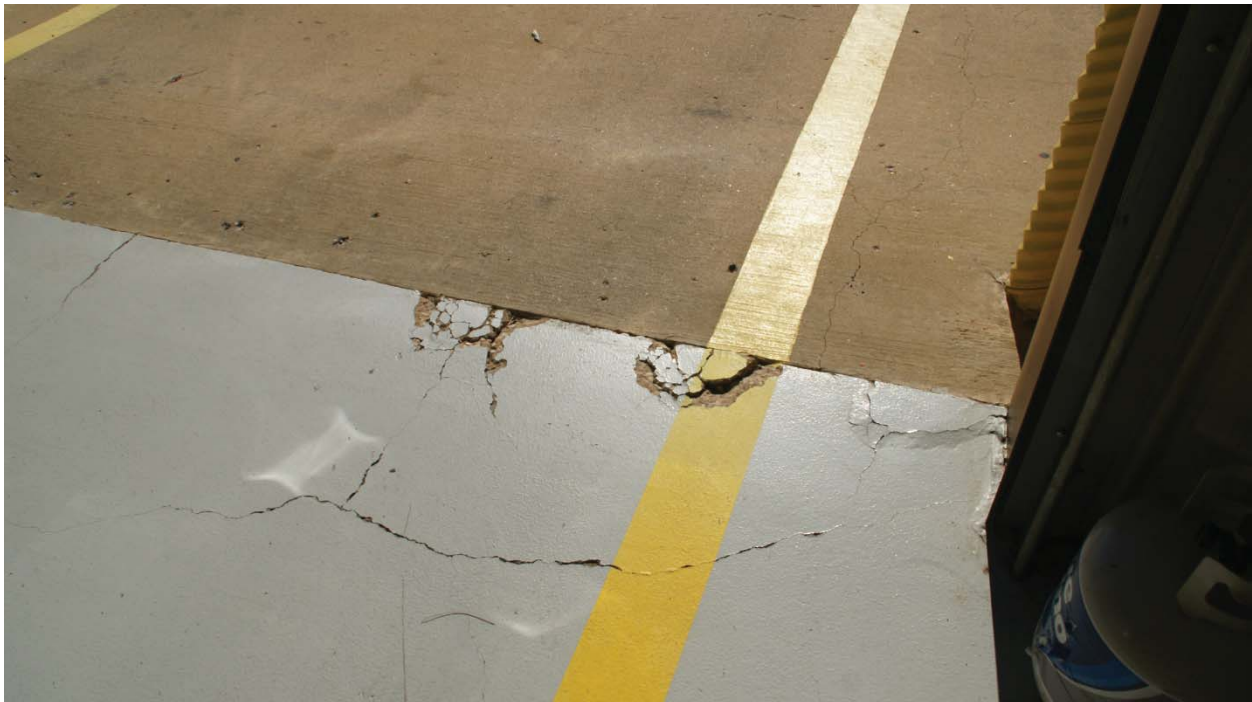
The slab on grade edges leading from the interior to the exterior is cracked due to inadequate wheel load transfer. Inadequate edge thickness and cover over dowels is the likely culprit. The cracking should be repaired to prevent water from entering the sub-base that could lead to disking of the pavement (pot holes).

*Photo S15. Edge of Slab Cracking Due to Wheel Loads at Vehicle Bays*

- Repair of the vehicle bay slabs is recommended to prevent maintenance issues in the future.
- Converting the area between the north and south wings to a concrete drainage swale would be an improvement to the current conditions.

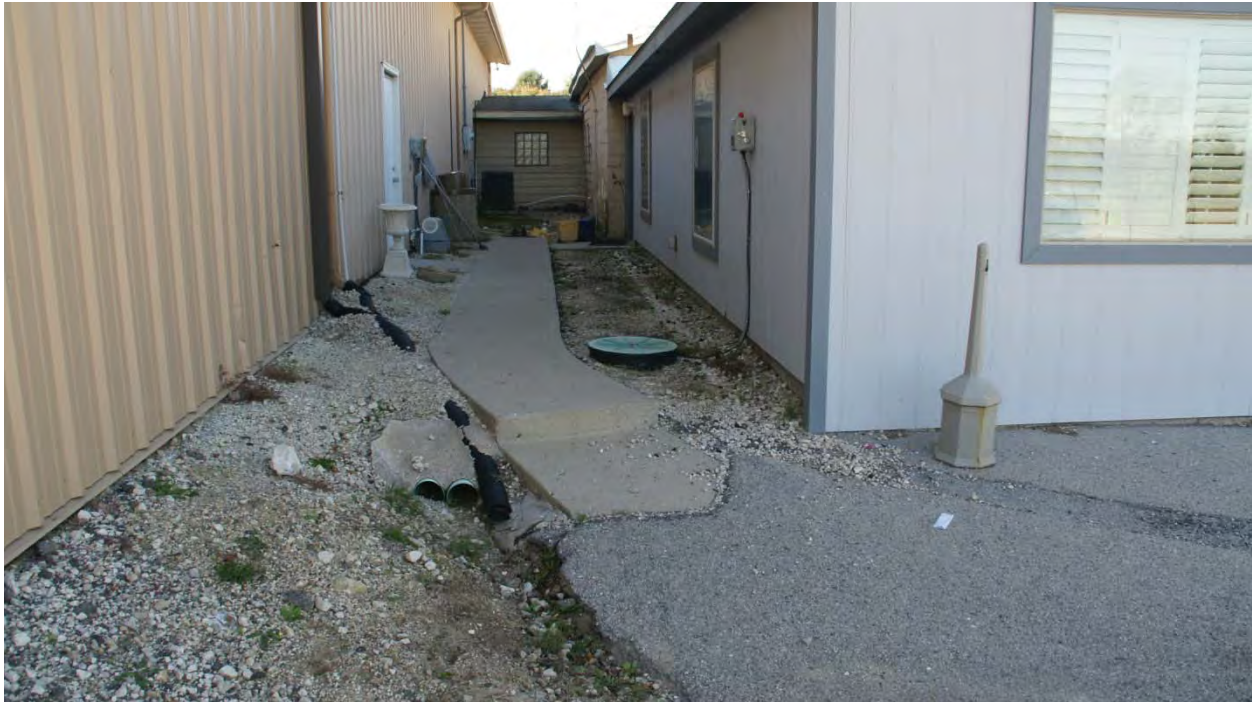
The area between the north and south wings of the fire station is in need of improvement from a drainage standpoint. A concrete swale with proper slopes could serve as a combination swale and splash block. Grass will not grow in this area, so the concrete will prevent erosion. The location of the sanitary lift station, which appears to be a converted septic tank (500 gallons), is in an awkward location. The lid of the tank should be marked "No Step". One end of the tank is very close to the foundation of the 1990 addition.

*Photo S16. Area Between the North and South Wings*

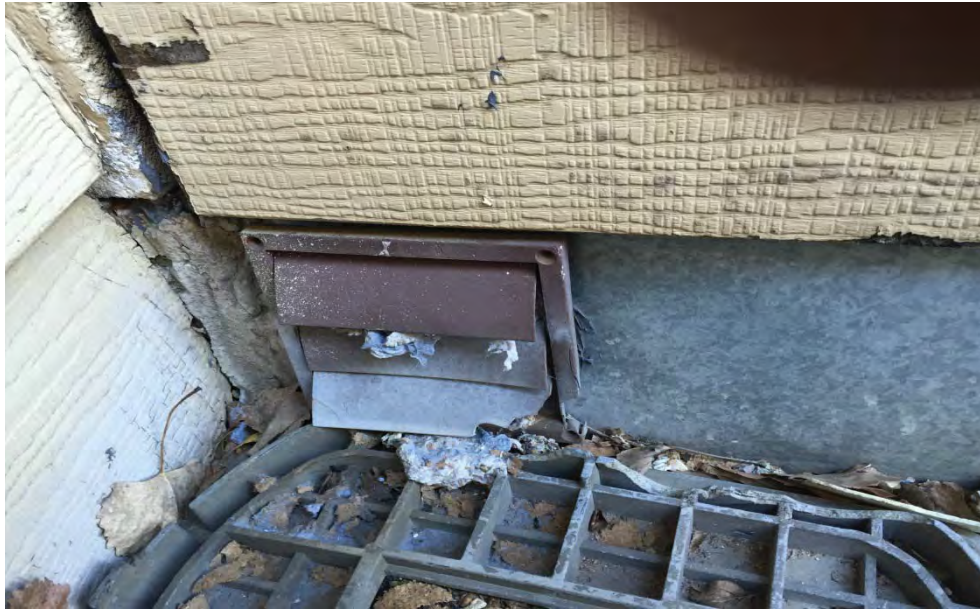
Dryer exhaust ductwork apparently is full of the lint and need either to be cleaned or replaced with new exhaust duct.

*Photo M1. Clogged Dryer Exhaust Backdraft Damper*

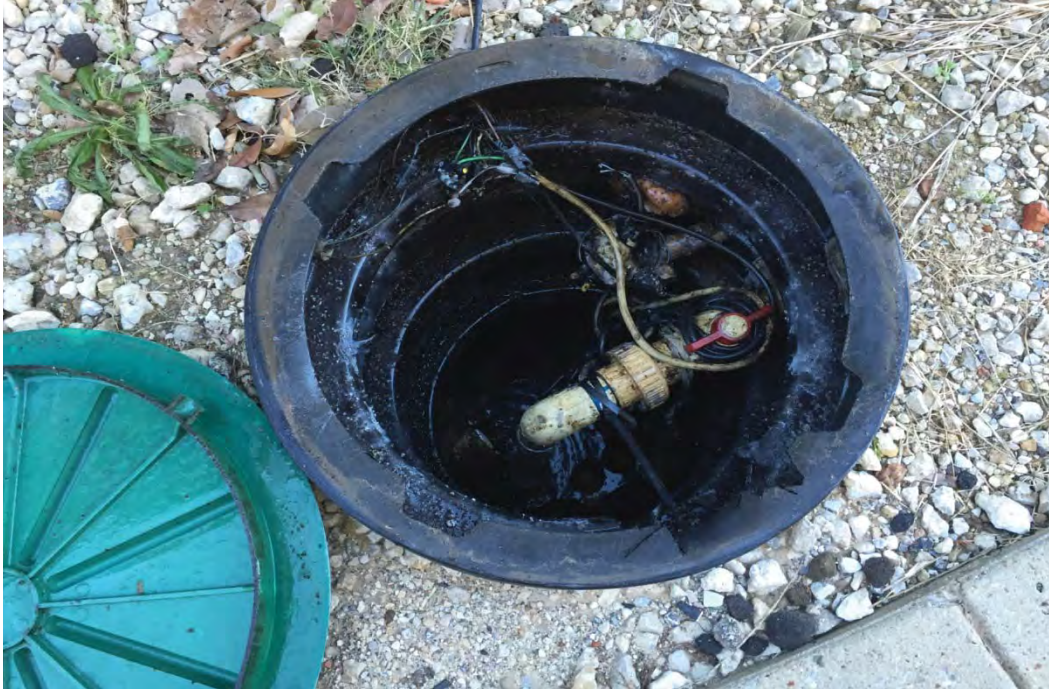
The sanitary sewer from the building is discharged into originally built septic tank later converted into the lift station. Existing ¼ HP pump provides lift into the city sanitary waste pipe north of the facility. Existing tank size and the pump configuration do not meet current plumbing code requirements. Larger tank size and a duplex grinder pump shall be provided for the facility.

*Photo P1: Sanitary Pump and Septic Tank*

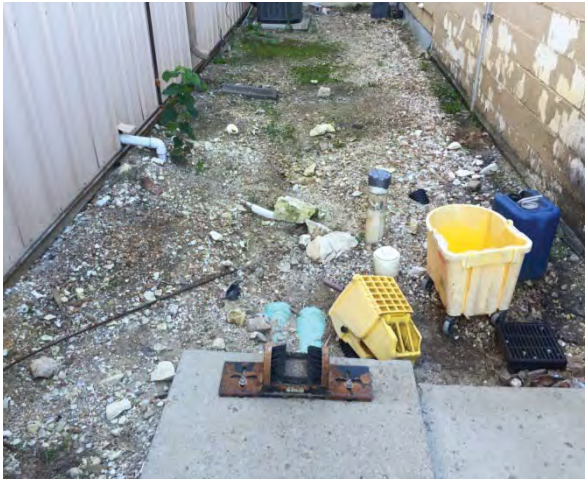
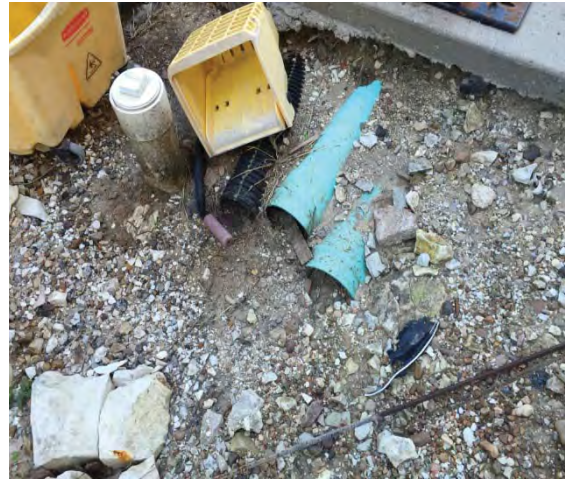
*Photos P2/P3. Storm Drain Conditions*
