**Town of Fairview**  
**Collin County, Texas**

**Fire Station #1 - Condition Assessment Report**

January 2016

**HUITT-ZOLIARS**

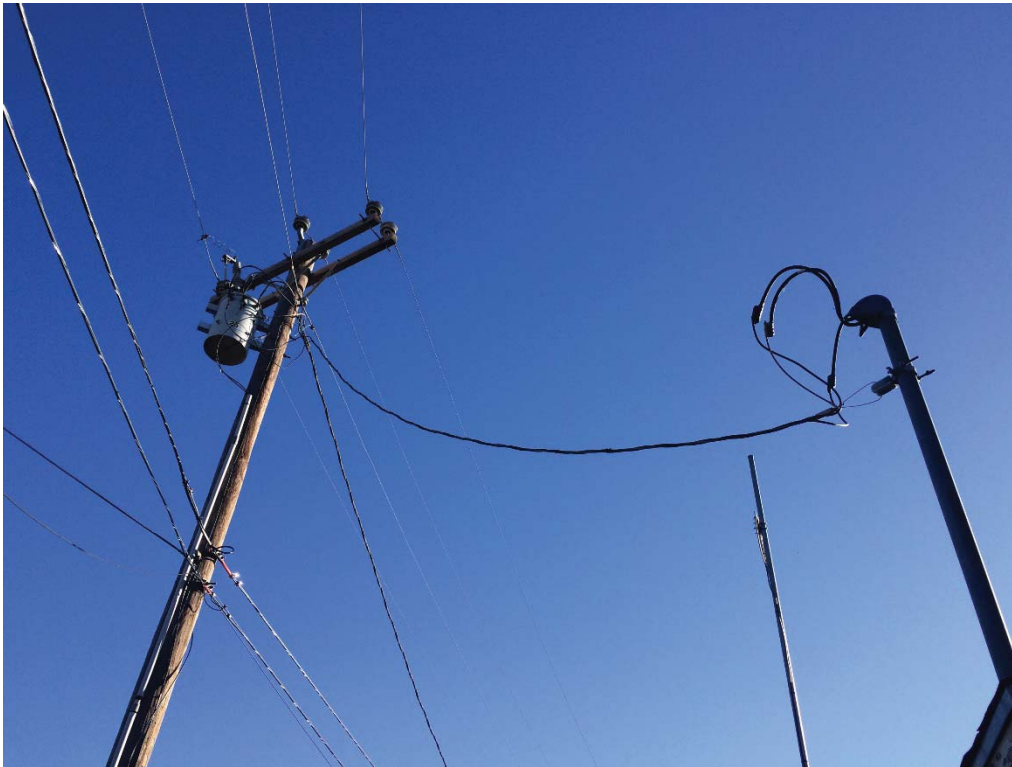
The facility electrical system is comprised of elements which have been added in stages through the years. Three separate electrical services from two different pole-mounted transformers provide power to the building. This violates NFPA 70 (NEC) Article 230.2 which limits buildings to a single service, with certain exceptions. Each 240/120V single-phase service terminates in a 200 amp panelboard. Two of the three panels are not labeled a being suitable for use as service equipment as required by NEC Article 230.66.

*Photo E1. Overhead Service*

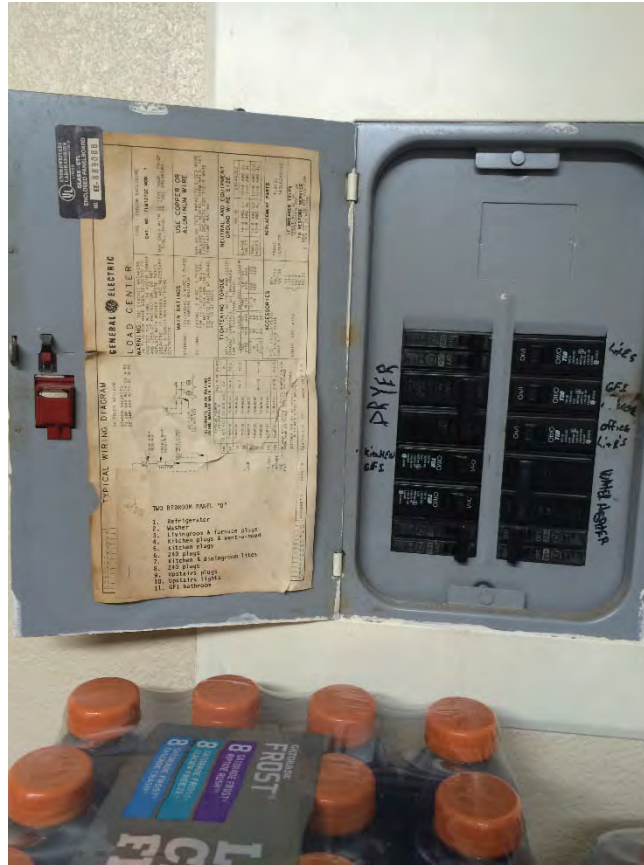
Photo E2. Sub-Panel Blocked by Stored Items

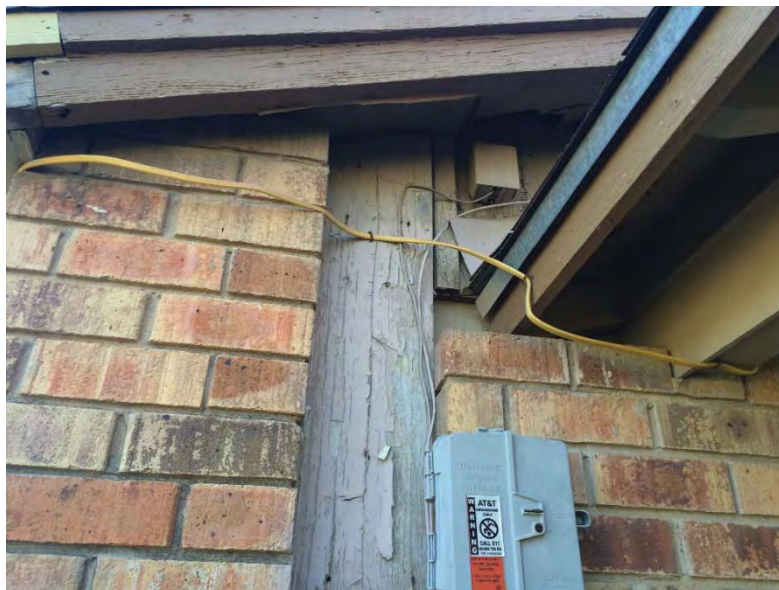
The oldest portion of the building (originally a residence) contains nonmetallic sheathed (“Romex”) wiring. While it is understood that total replacement of this wiring is not feasible, it appears that some devices were wired with this material after its conversion to a commercial facility. Furthermore, this cable was used outdoors exposed to the elements. This is a violation of NEC Article 334.15.

Photo E3. Improper Use of Type NM Cable

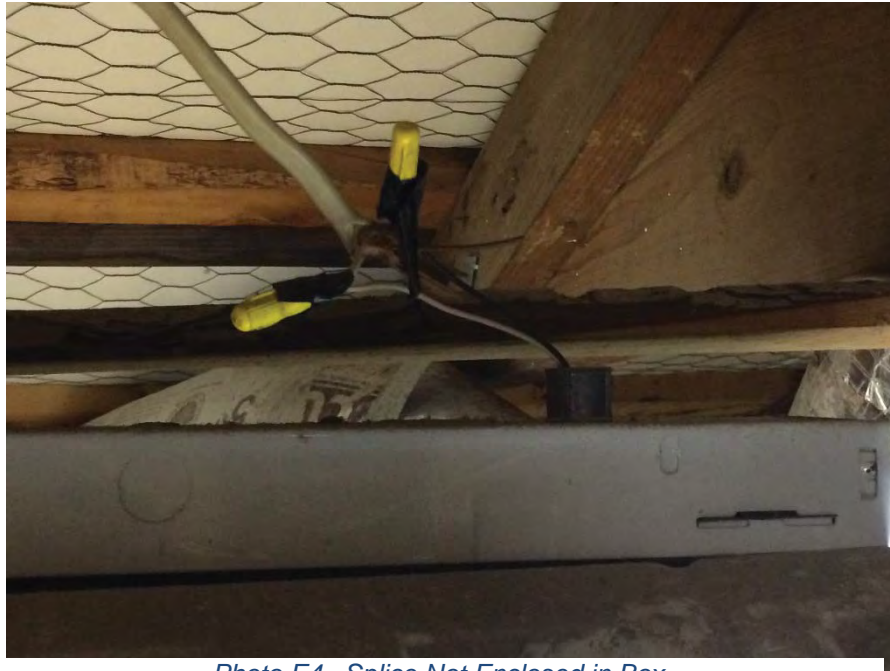
NEC violations were also noted in regard to cable terminations and splices. Conduits and cables are required to be securely attached to boxes and fixtures. Splices must only occur within boxes or listed enclosures. At least two examples of improper splices and/or cable terminations were found.

*Photo E4. Splice Not Enclosed in Box*

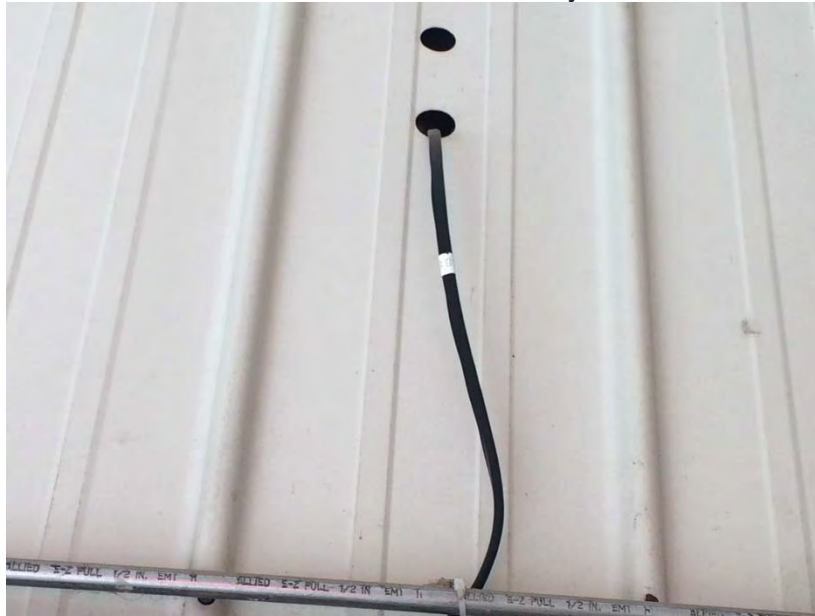
*Photo E5. Cable Through Wall Panel Without Protective Bushing*

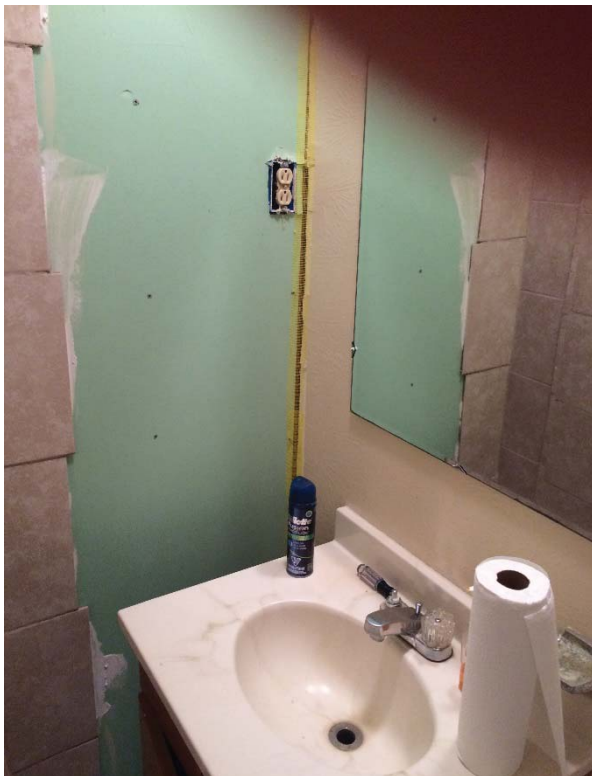
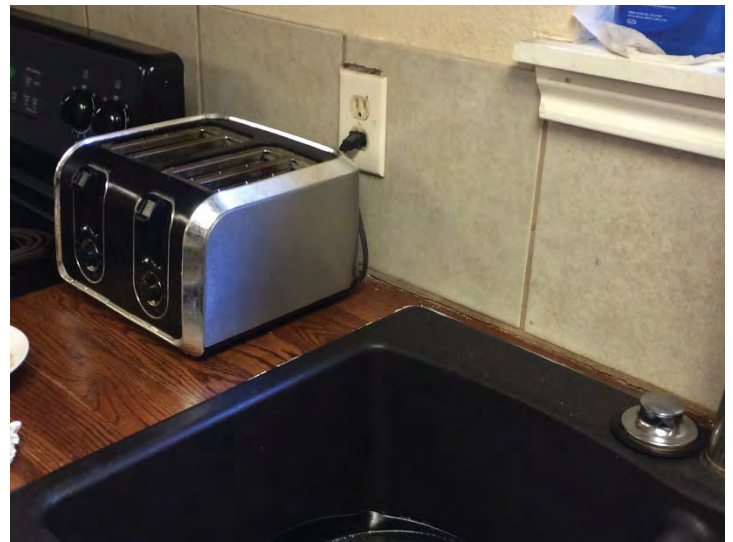
Receptacles with ground fault circuit interrupters are required in bathrooms and within six feet of any sink. Two receptacle locations were found in violation of this NEC requirement.

*Photos E6/E7. Receptacles Requiring GFCI Protection*

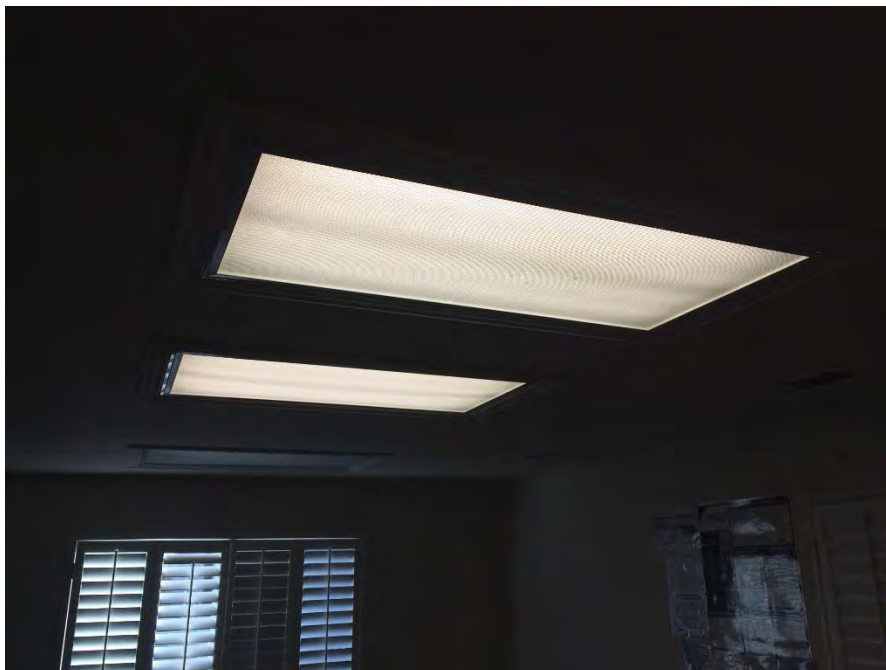
The facility lighting is a broad variety of fixture types employing both incandescent and fluorescent lamps of various types. A limited number of LED fixtures have been installed recently. Approximately 2/3 of the fixtures use linear T8 fluorescent lamps housed in either recessed or surface mounted troffers. This type of lamp is marginally acceptable in terms of energy efficiency. A number of other fixtures were found to use older T12 lamps, which are much less efficient than the T8 type.

*Photo E8. Typical Fluorescent Fixtures*

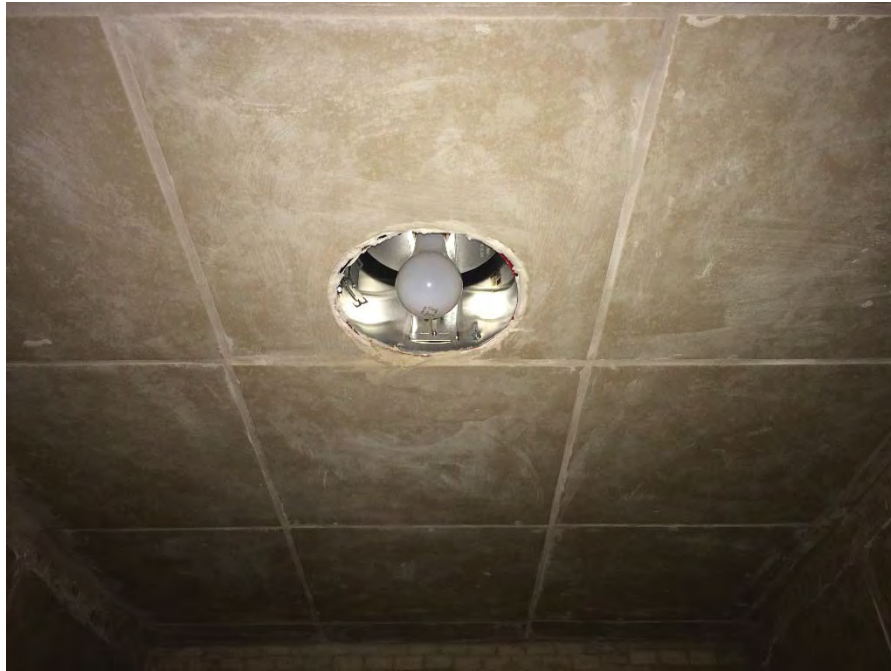
*Photo E9. Fixture in Shower*

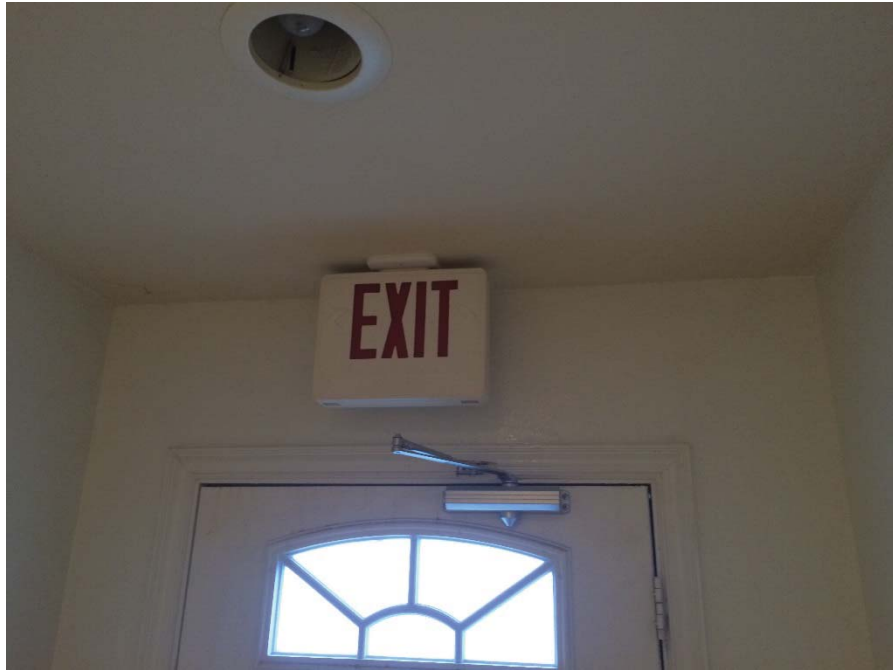
*Photo E10. Exit Light Not Working*

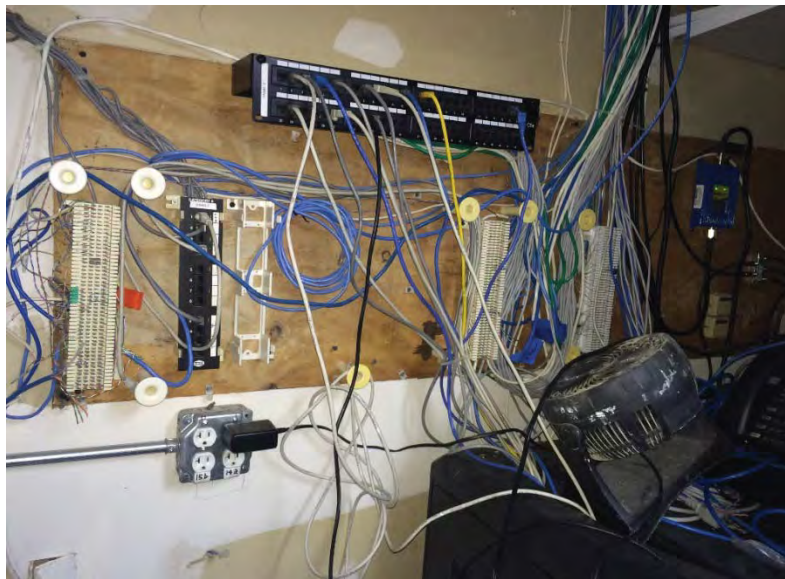
While this state of disorganization does not violate any safety codes, it would likely hamper any troubleshooting efforts when the need arises. The absence of labeling on most of the cables would compound this issue.

*Photo E11. Cluttered Cabling in Telephone Closet*
