**Town of Fairview**  
**Collin County, Texas**

**Fire Station #1 - Condition Assessment Report**

January 2016

**HUITT-ZOLIARS**

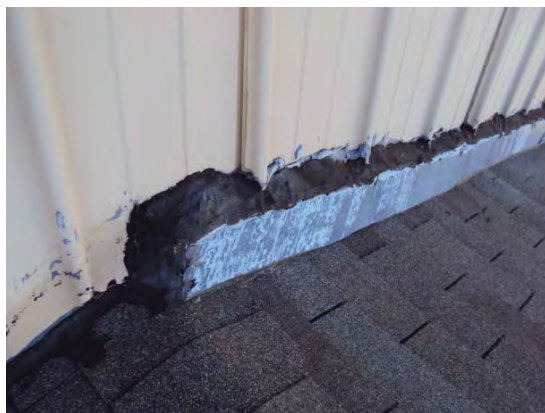
*Photo A6. Roof Flashing*

The vertical walls where the lower roofs intersect are not properly flashed, the materials and sealants are rapidly deteriorating. To properly address this problem, all the roofing, sidewalls, flashing and sheathing would need to be replaced. However, this would not address the real problem that has been created with existing construction and additions at various elevations and intersections.

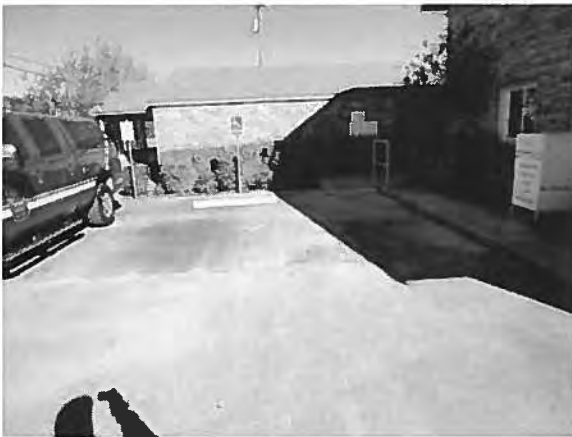
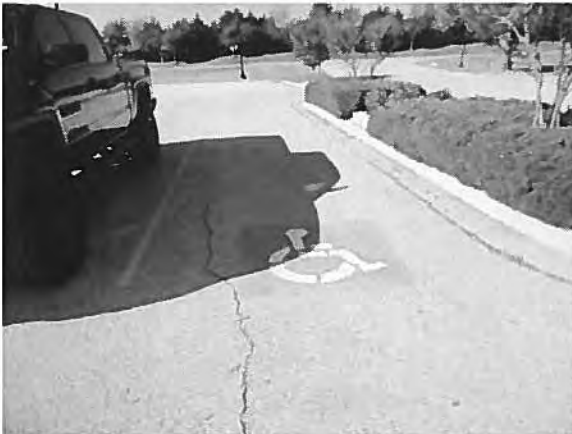
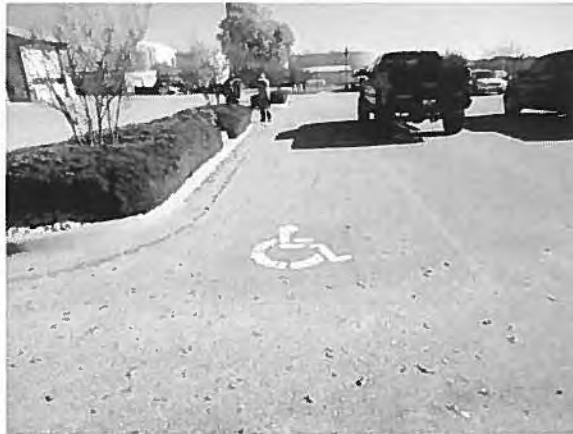
- 1. The accessible parking spaces did not provide access aisles.**
- 2. 2 of the accessible parking spaces were not identified with compliant accessible parking space signs.**

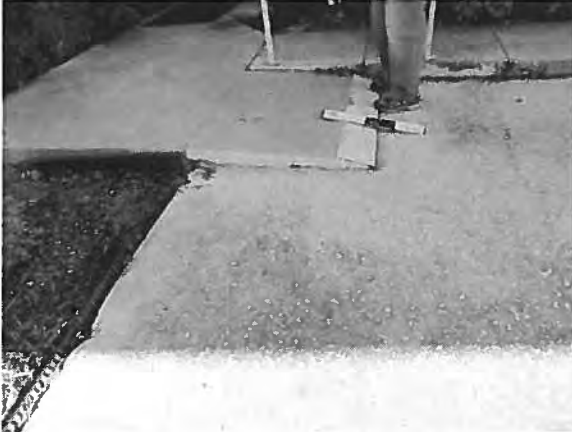
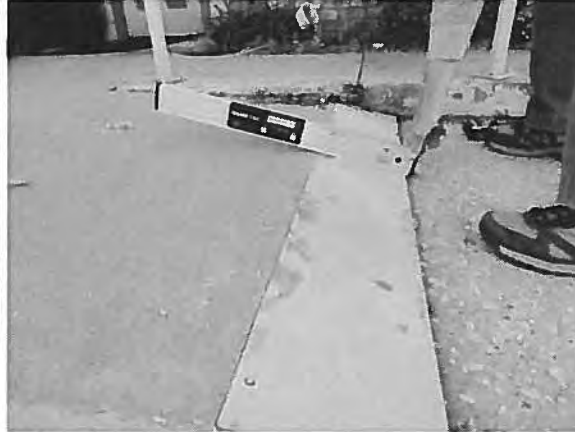
- 3. The ramp located in front of the entrance had a 26.4% running slope.**

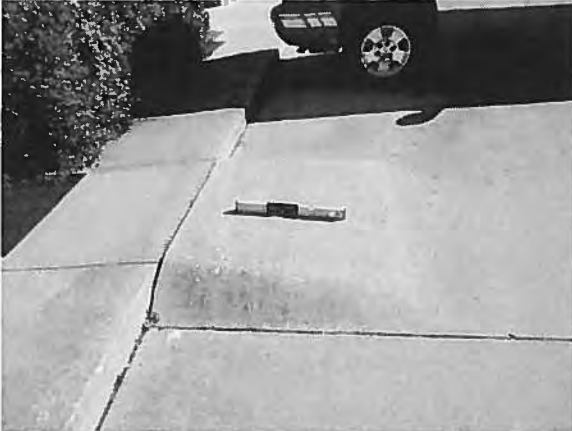
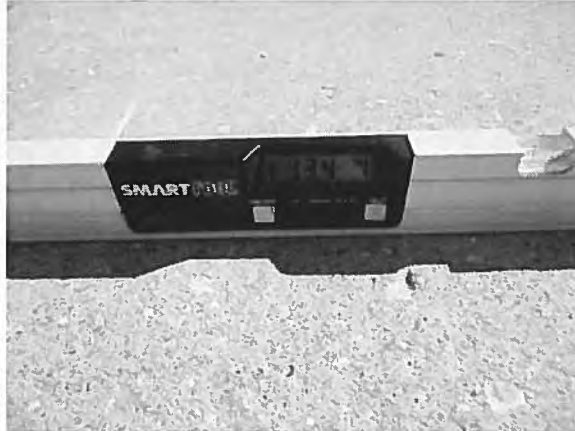
- 4. The curb ramp located outside of the fitness center had a 13.4% running slope.**

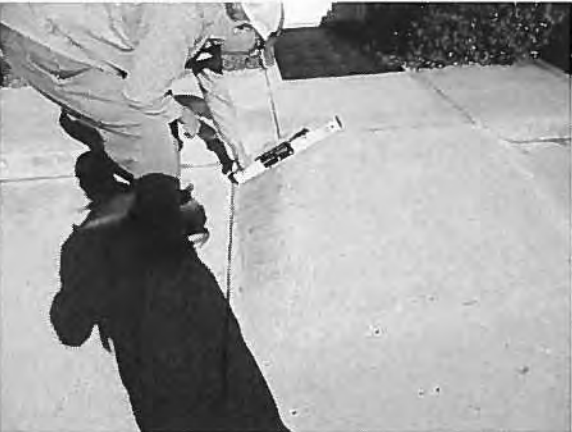
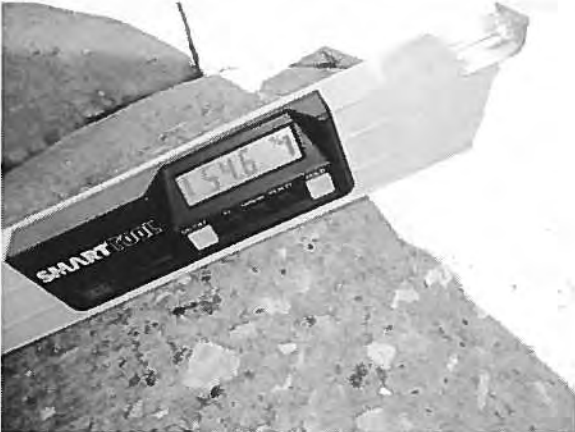
- 5. The curb ramp located outside of the fitness center had side flares with a 54.6% slope.**

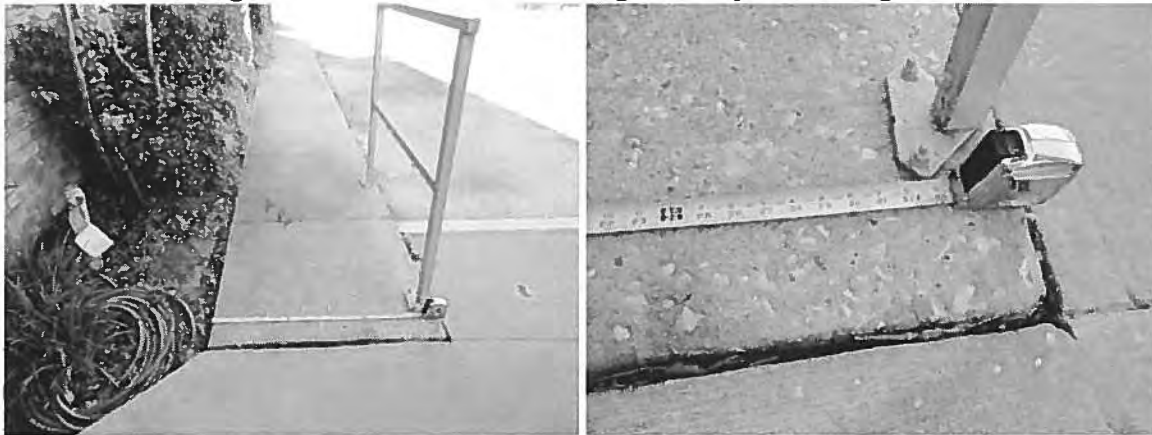
6. The sidewalk located in front of the entry does not provide an accessible width walking surface. The handrail is 48" long and only provides a 32" wide accessible route/ walking surface – edge of walk to the inside edge of to post/railing.

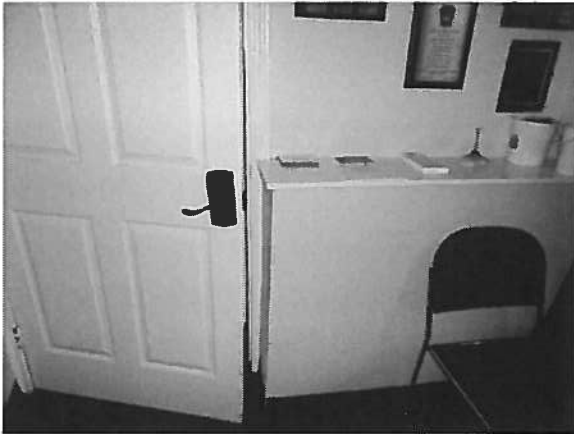
**7. The door connecting the entry and waiting room does not provide any door maneuvering clearance on the pull side of the door for front approach.**

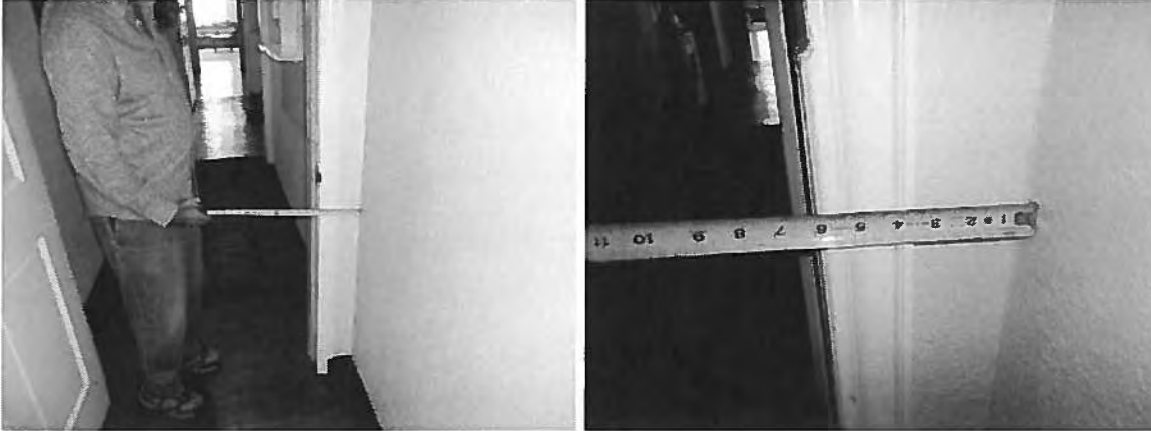
- 8. The door connecting corridor #1 and corridor #2 provides only 6" from the side wall to the strike side of the door for front approach on the pull side.**

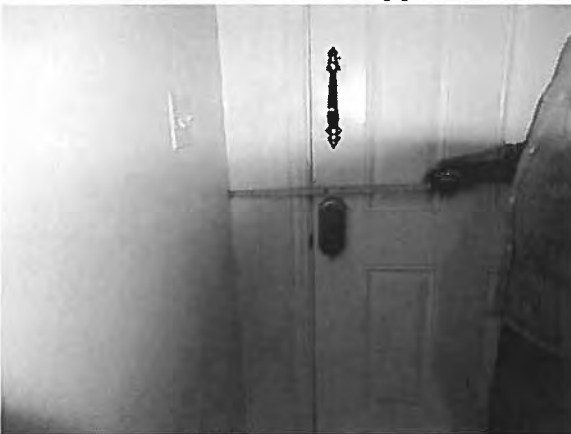
- 9. The exterior door located in corridor #4 provides only 10" from the side wall to the strike side of the door for front approach on the pull side.**

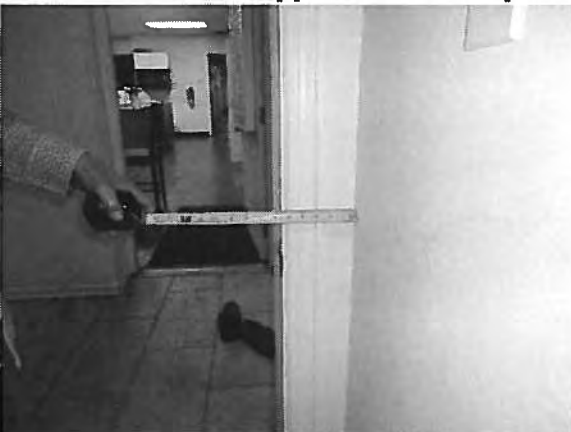
- 10. The door located in corridor #4 provides only 5-1/2" from the side wall to the strike side of the door for front approach on the pull side.**

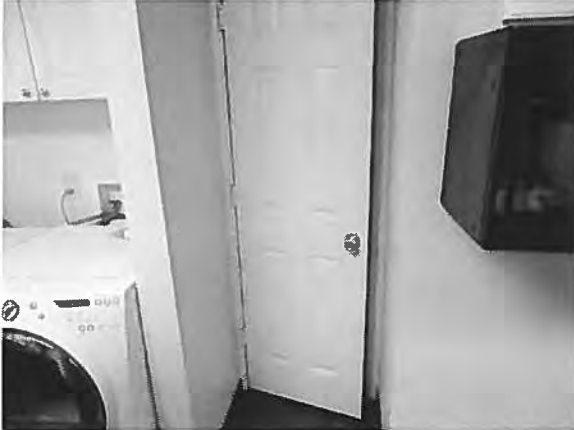
**11. The door located at shower #1 provided only 2-1/2" from the side wall to the strike side of the door for front approach on the pull side.**

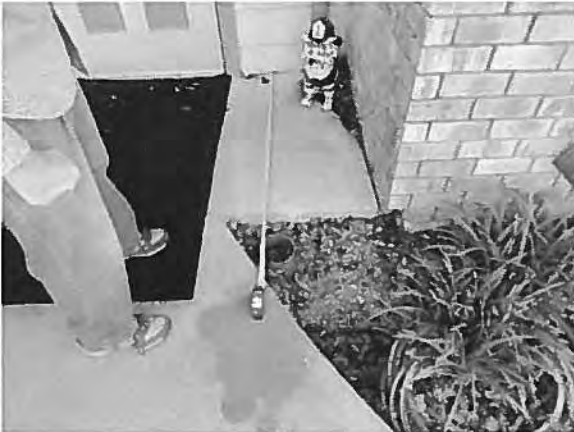
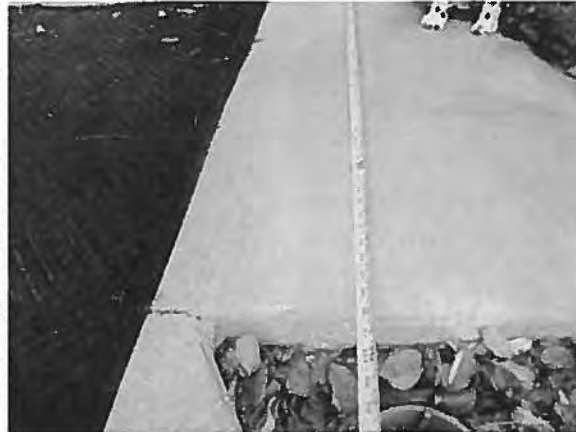
**12. The entry door does not provide the 60" minimum door maneuvering area for front approach on the pull side.**

**Only 46" door maneuvering clearance is provided on the strike side of the door,**

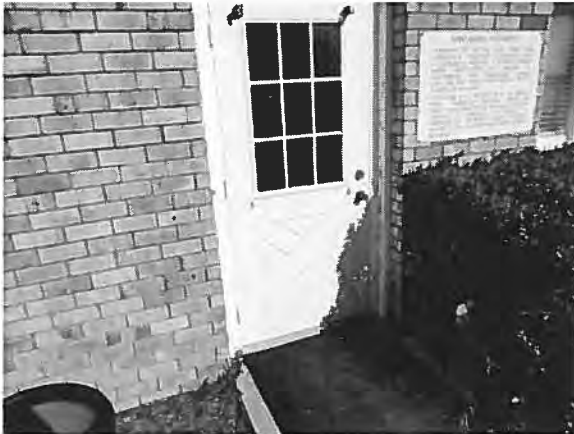
**13. The exterior fitness center door provided only 4" door maneuvering from the strike side of the door to the side of the brick.**

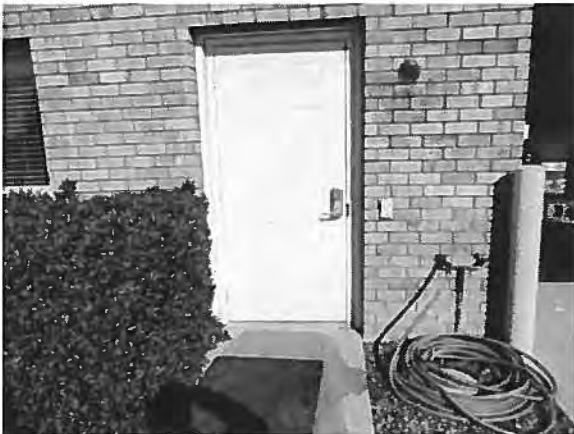
**14. The exterior vehicle bay door provided only 4" door maneuvering from the strike side of the door to the side of the brick.**

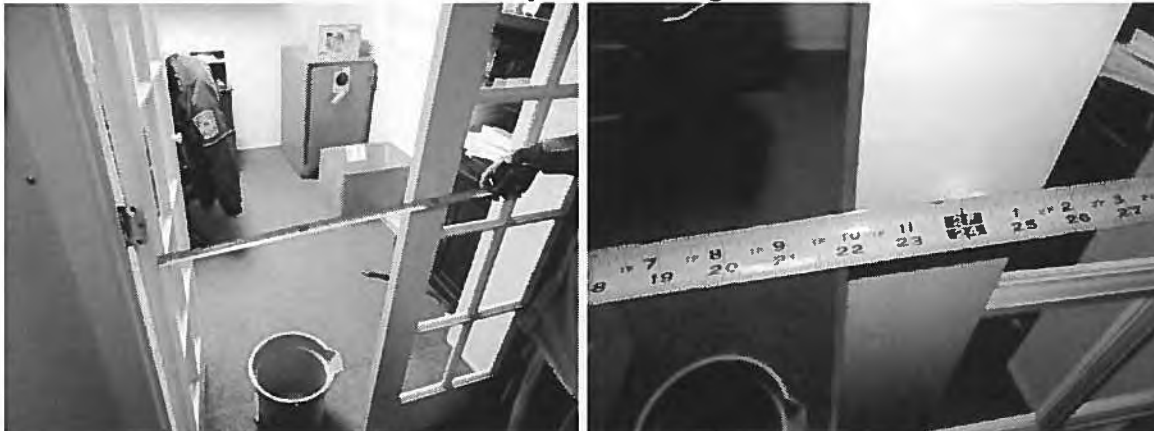
**15. The double doors located in office #5 are a pair of 22" doors and only provide a 22" wide clear width when one of the doors open at 90 degrees.**

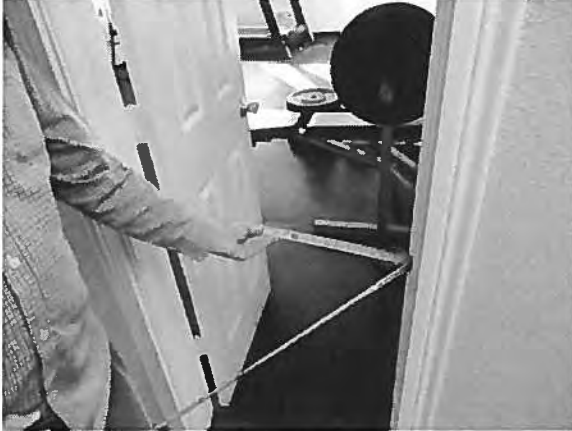
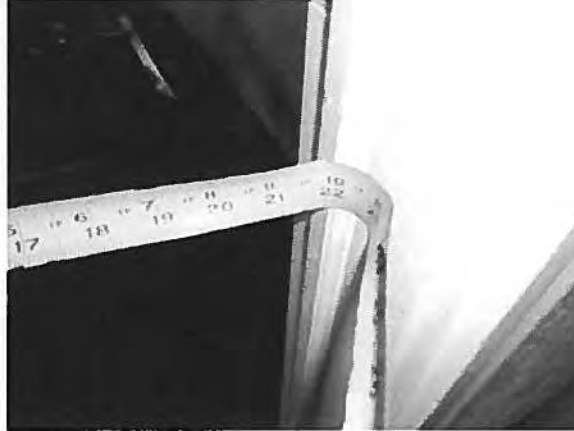
**Door connecting the fitness room and corridor #3**

**16. The following doors provided only a 22" wide clear width with the door opened at 90 degrees.**

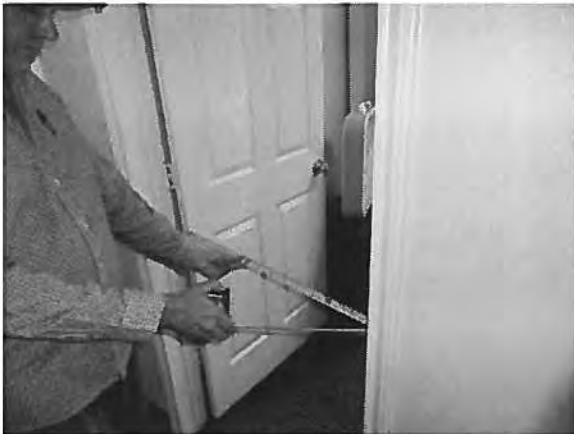
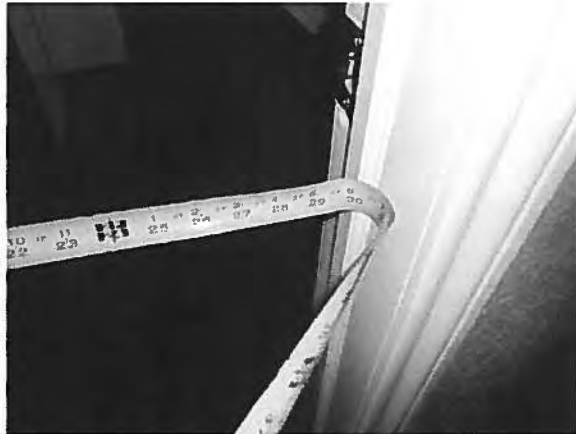
**17. Bedrooms #1, #2, #3, and #4 doors provided only a 30" wide clear width with the doors open 90 degrees.**

**Note: Only one bedroom is required to comply with the 2012 TAS  
See TM 2012-02 Attached.**

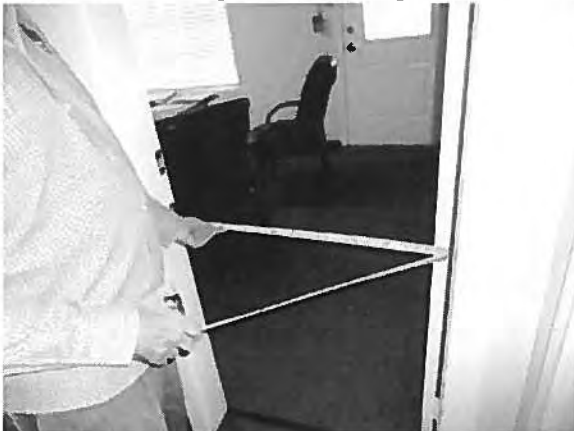
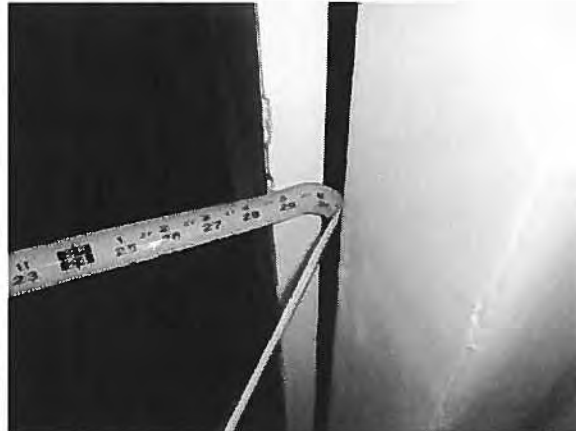
**18. Office #1 door provided only a 28-1/2" wide clear width with the door open 90 degrees.**

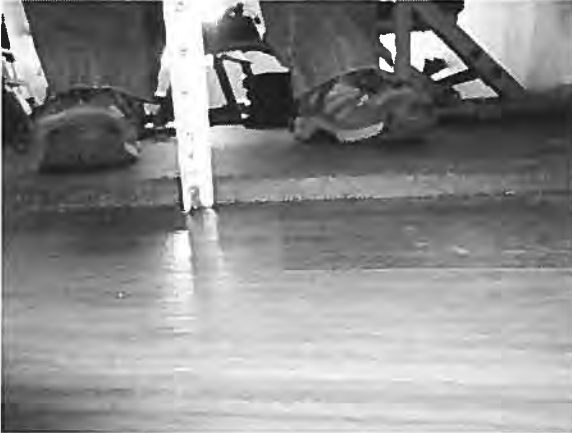
**21. The fitness center interior door had a threshold/ vertical edge level change of  $\frac{3}{4}$ ".**

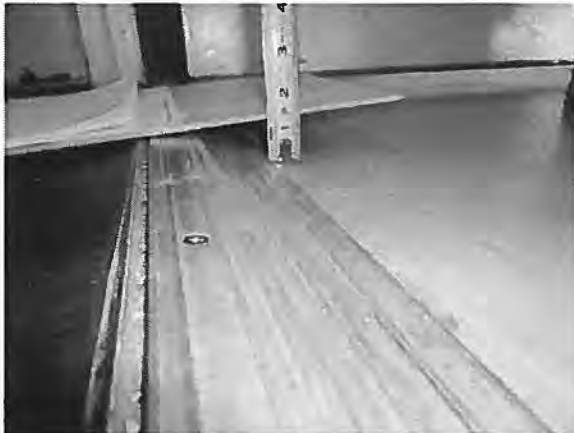
**22. The door connecting the vehicle bay and corridor #4 had a threshold of 1-1/4" from the top of the threshold to the finished floor.**

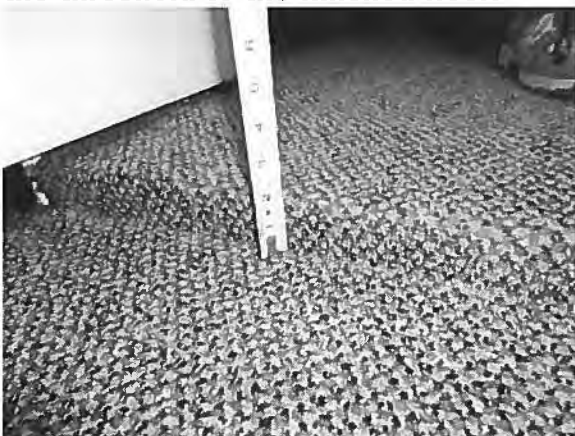
**23. The double doors in Office #5 has a vertical edge threshold hold measured 2" from the top of the threshold to the finished floor.**

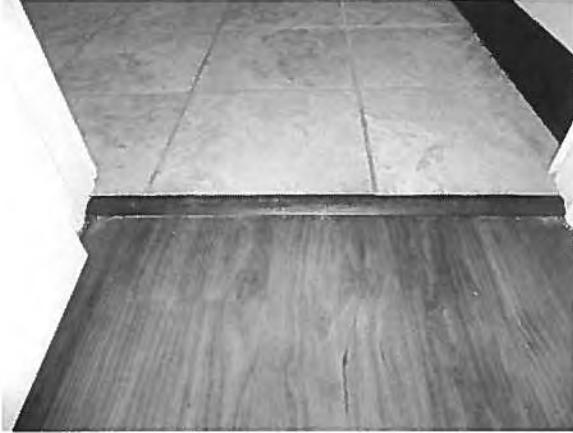
**24. Shower #1 had a 3/4" high threshold that was not properly beveled.**

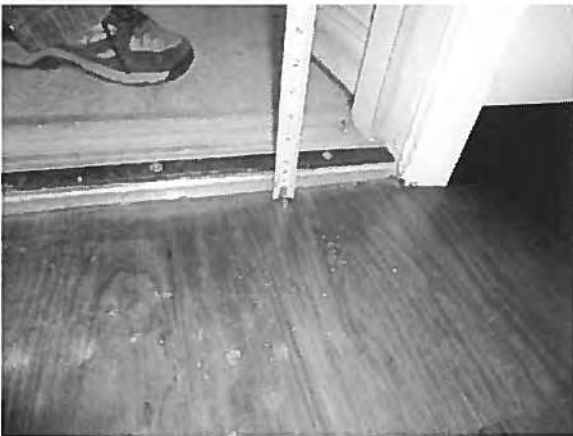
**25. The door connecting the kitchen to corridor #4 had a 3/4" high vertical edge at the threshold of the door.**

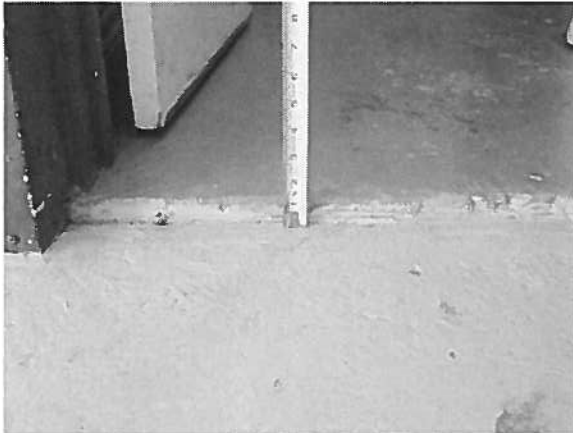
**29. The vehicle restroom door had a 3/4" high vertical edge at the threshold of the door.**

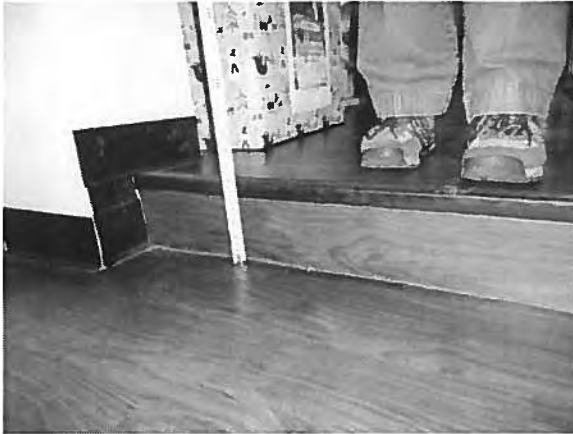
**30. There is 6" level change located in corridor #2 located on an accessible route.**

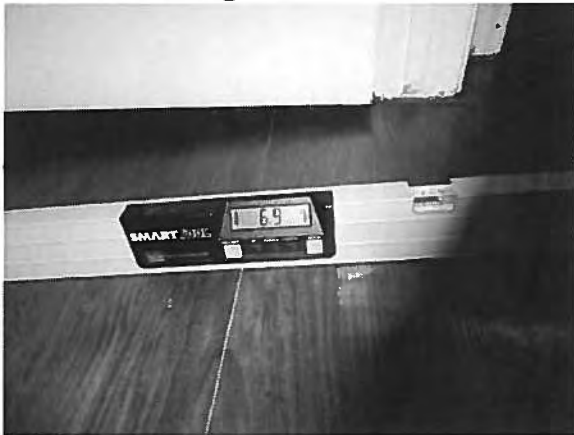
**31. The door connecting the entry to the waiting room had a 6.9% running slope in the door maneuvering area.**

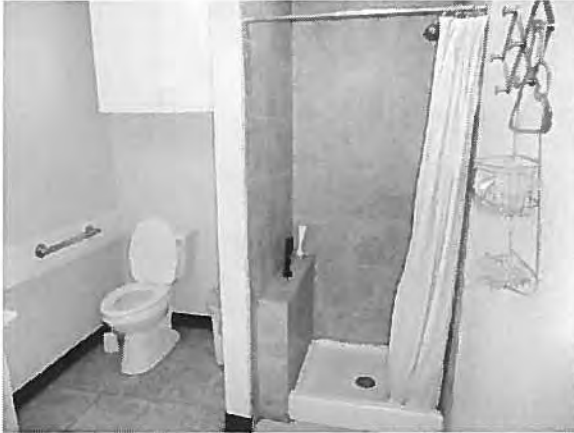
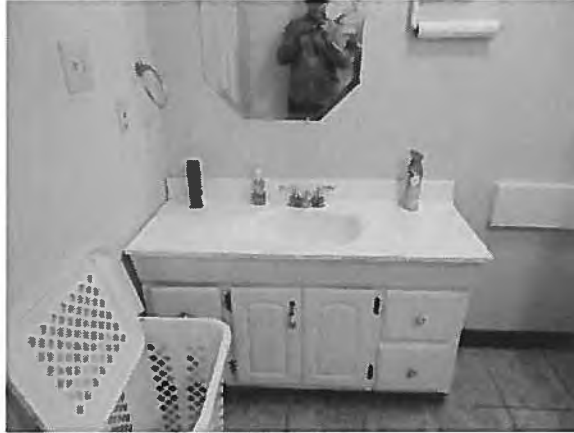
**Shower #1**

**33. Shower #1, Shower #2, and Vehicle RR – bathrooms were not designed to be accessible. Bathrooms are allowed to be adaptable in residential dwelling units. See exceptions below**

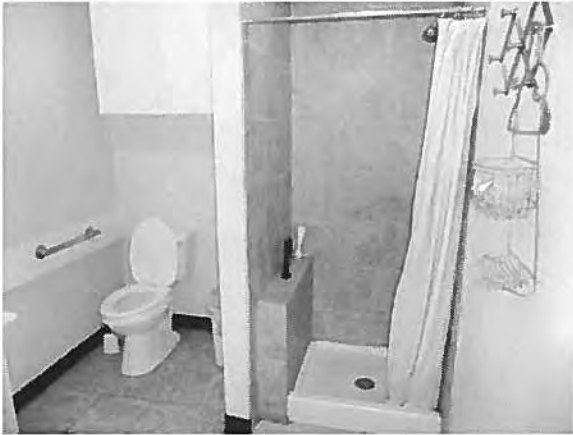
**34. Shower #1 and Shower #2 – A shower spray unit with a hose that can be used both as a fixed shower head and as a hand-held shower head was not provided. The fixed shower head measured more than 48” above the finished floor.**

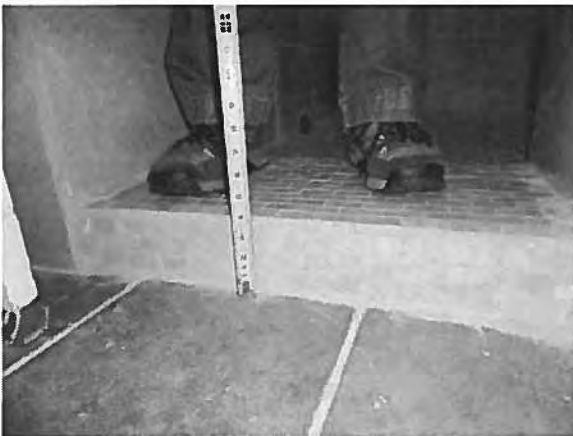
**35. Shower #2 – the shower threshold measured 4” from the top of the threshold to the finished floor.**

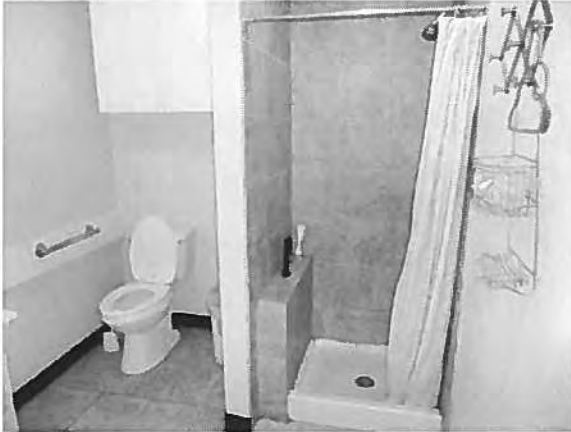
**36. Shower #1 – the shower threshold measured 5-1/2” from the top of the threshold to the finished floor.**

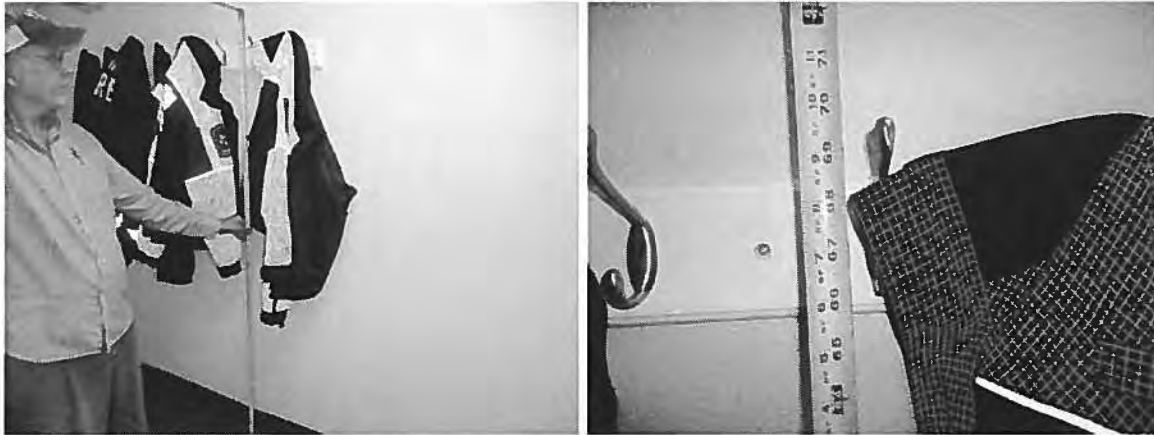
**37. The coat hooks located in corridor #3 measured 69-1/2" from the top of the coat hook to the finished floor.**

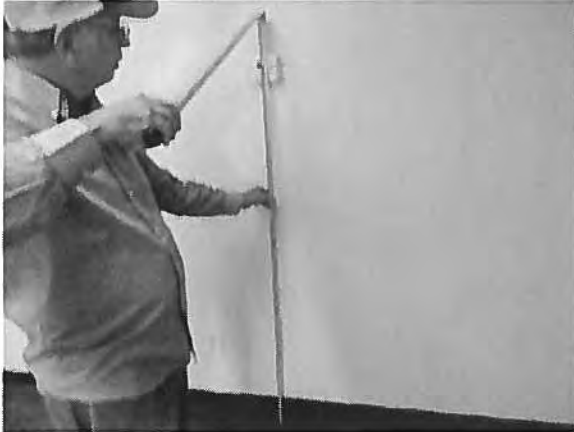
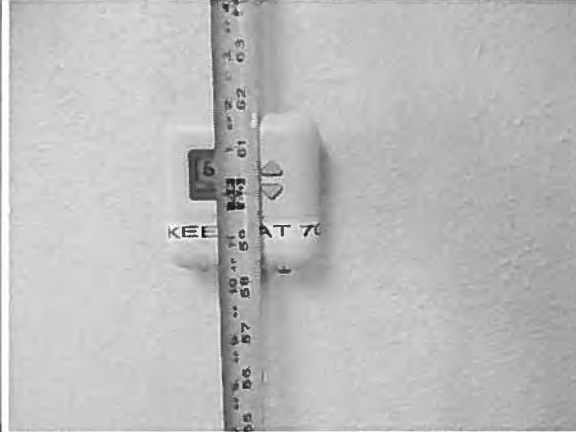
**38. The thermostat located in corridor #3 measured 60-1/2" from the top of the operable part to the finished floor.**

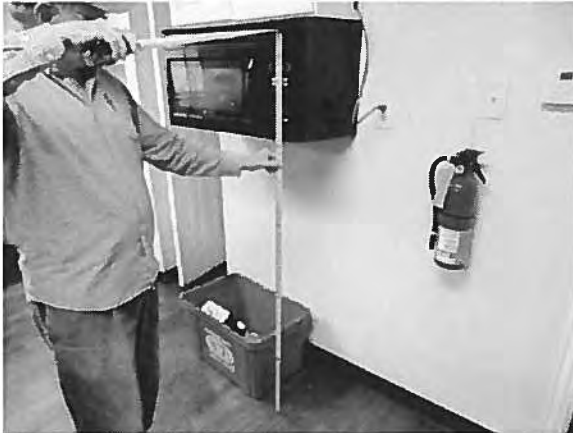
**39. Kitchen - The operable parts on the microwave measured 57" from the finished floor.**

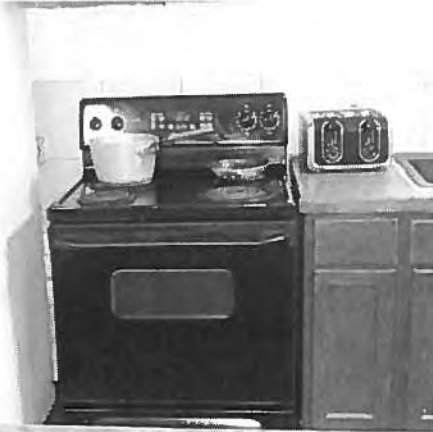
**40. The range/oven located in the kitchen has the controls located above the burners. A user would have to reach over the burners to operate the range/oven.**

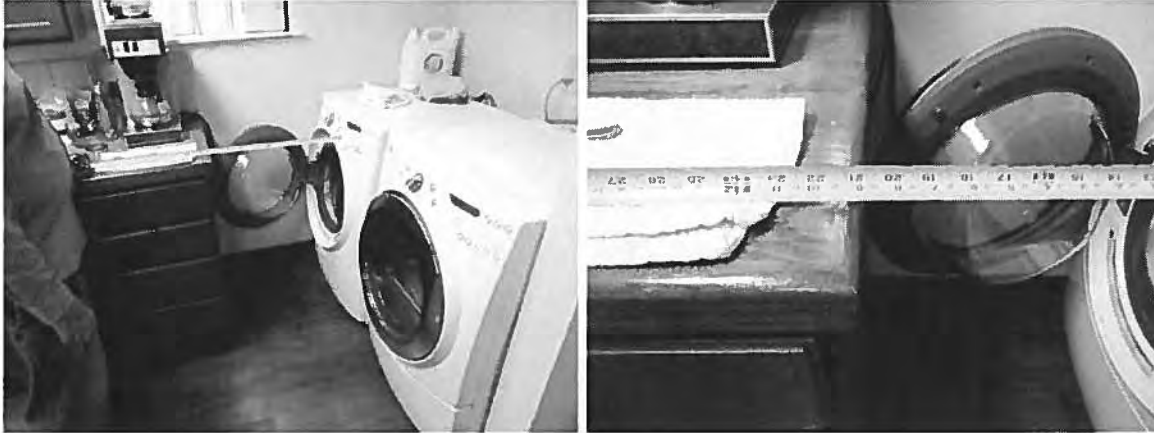
**42. The washer located in the kitchen did not provide a clear floor space complying with 305. The distance from the front of the washer to the adjacent counter-top measured 21" wide.**

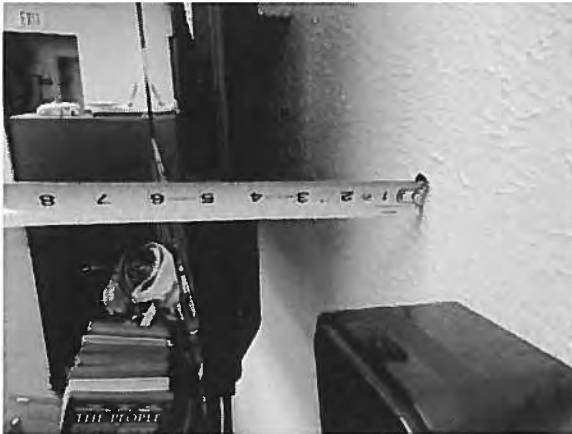
**43. The Television located in the recreation room protrudes 5-1/2" from the wall at a height above 27".**

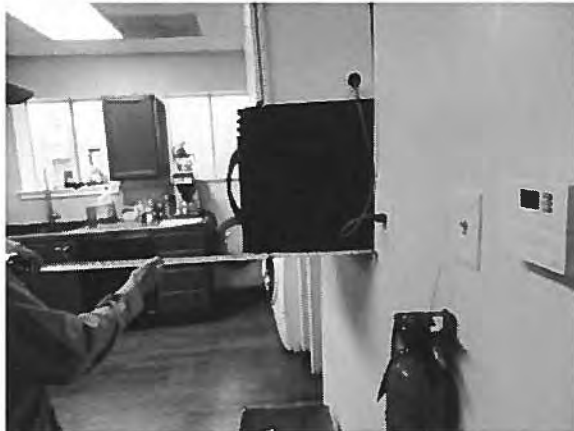
**44. The microwave located in the kitchen protrudes 15" from the wall at a height above 27".**

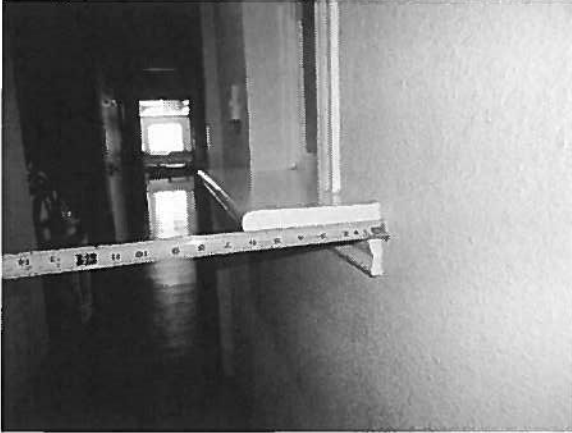
45. The reception shelf/counter located in corridor #2 protrudes 6-1/4" from the wall at a height above 27".

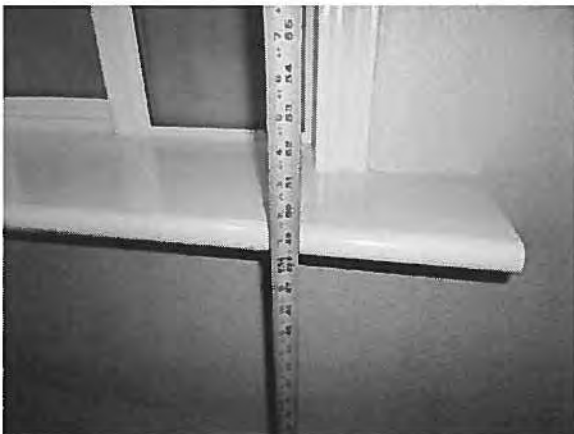
46. The transaction/ service counter located in corridor #2 measured 49-1/2 from the top of the counter to the finished floor.
